GROUP	MODEL
Safety Recall Campaign	2015-2019MY Soul EV (PS EV)
NUMBER	DATE
SC267 (Rev 1, 08/31/2023)	August 2023

HIGH-VOLTAGE BATTERY PACK AND BATTERY MANAGEMENT SYSTEM (SC267)

This bulletin provides information regarding High-Voltage Battery Pack and Battery Management System (BMS) for the subject vehicles below. An electrical short circuit between the anode and cathode of the battery cells can occur within the high-voltage battery pack assembly (BPA) case located underneath the vehicle. If an electrical short circuit occurs, a fire may result while driving, thereby increasing the risk of injury.

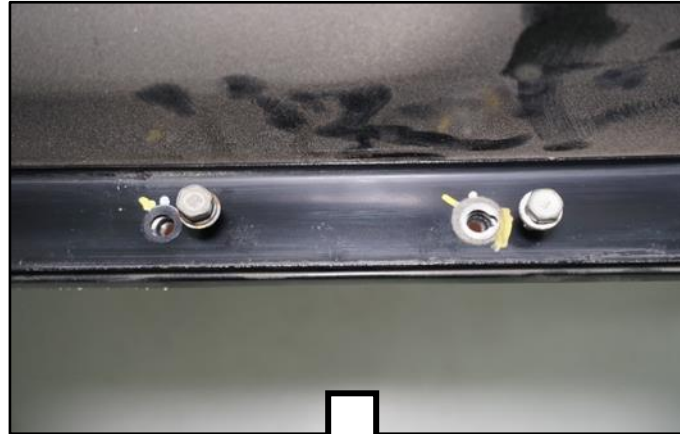
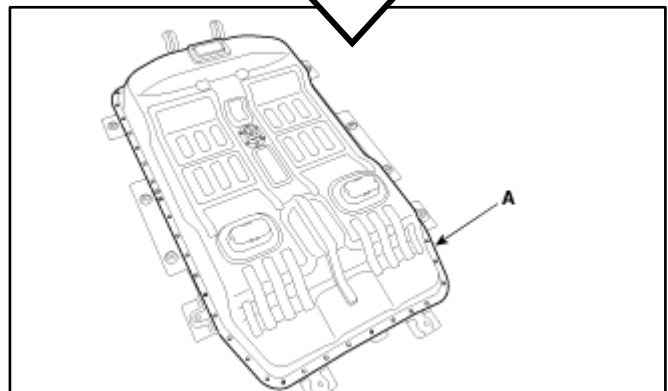
2. Verify the 2nd to last letter of the Battery Pack Assembly (BPA) shown and take a photo of the label using KVID and attach it to the claim:

- **A or B:** Replace BMS ECU and VTSWH (Page 10) and upgrade the BMS ECU Software (Page 3).
- **W or X:** No further action required. Reinstall all removed parts in the reverse order of removal and confirm normal vehicle operation.

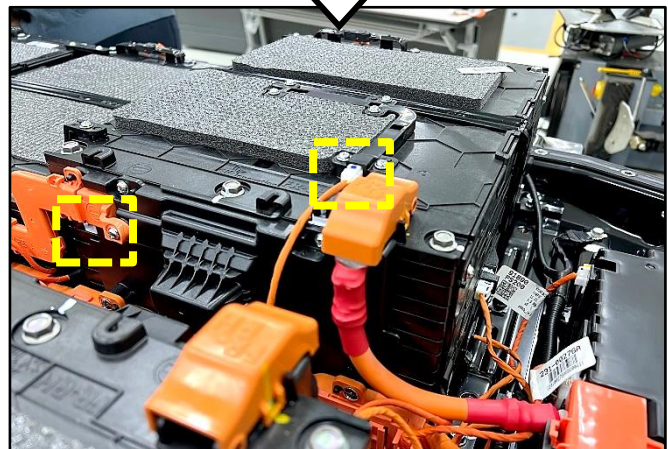
- Reinstall all removed parts in the reverse order of removal.
- Perform the BCM Software Upgrade as outlined on page 3.
- Confirm normal vehicle operation.
- Using KDS, scan for related DTC described on page 2. Are related DTC(s) present?

- YES (NG)** - Related DTC(s) are stored. Replace the BPA Assembly (Page 12)
- NO (OK)** - No DTC(s) or Non-Related DTC(s) stored. Campaign is complete.

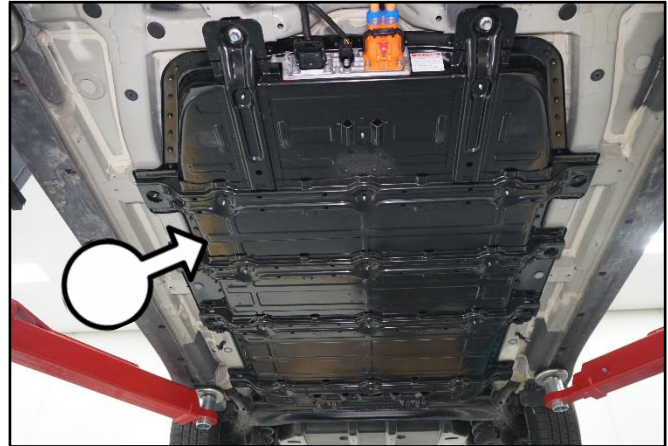
15-17MY ONLY new **BPA** is equipped with an "old" type harness. Be sure to swap/install the "new" type harness.

1. Replace the HV BPA by referring to "EV Battery System → High Voltage Battery System → Battery Pack Assembly → Repair procedures (Removal)" in the applicable Shop Manual on KGIS.
