Safety Recall

N222375270 Brake Pressure Switch Connector Fire

Release Date: June 2023

Condition	General Motors has decided that a defect which relates to motor vehicle safety may exist in certain 2019-2023 model year Chevrolet Silverado Medium Duty 4500HD/5500HD/6500HD vehicles. These vehicles may have a brake pressure sensor assembly that allows brake fluid to leak beyond the diaphragm seal into the pressure switch. The brake fluid may seep into the sensor's electrical components and short the brake pressure switch and the associated fuse. If brake fluid shorts the brake pressure switch and the associated fuse, the circuit can generate excessive heat that could result in a fire, increasing the risk of injury. An underhood fire may occur when the vehicle is off and possibly unattended.
Correction	Dealers will replace the master cylinder pressure sensor. Dealers will also inspect the associated wire harness and replace if necessary.

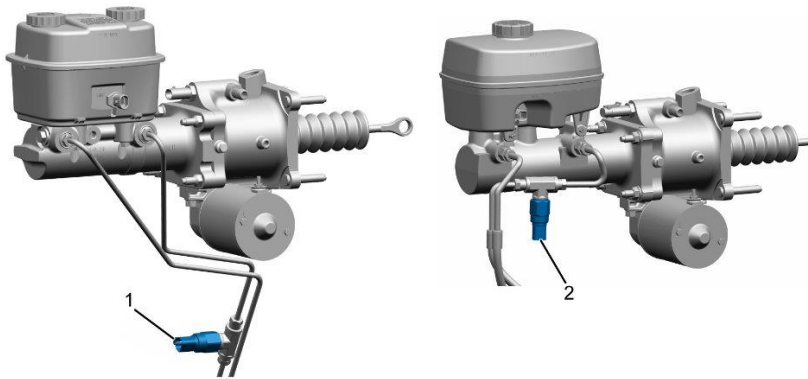
6361845

Note: Vehicles built on or before 11/30/2020 will have the Brake Pressure Switch located in position (1). Vehicles built on or after 12/01/2020 will have the Brake Pressure Switch located in position (2).

6. Locate the Brake Pressure Switch (1) or (2) depending on build date.

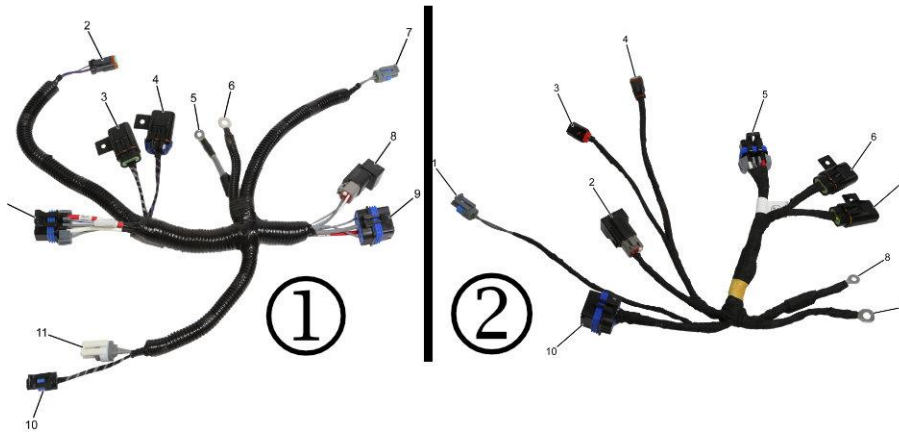
6366283

Note: The wire harness routing varies based upon build date. Vehicles built on or before 11/30/2020 are shown on the left (1). Vehicles built on or after 12/01/2020 are shown on the right (2).

27. Using previously recorded routing and slipping locations, route new harness as noted in step 24, installing cable tie straps where previously located.
