RAM

Remedy available for
 2019-2021 (VF) Ram ProMaster

Park Engagement

Reference: 61A / NHTSA 23V-301

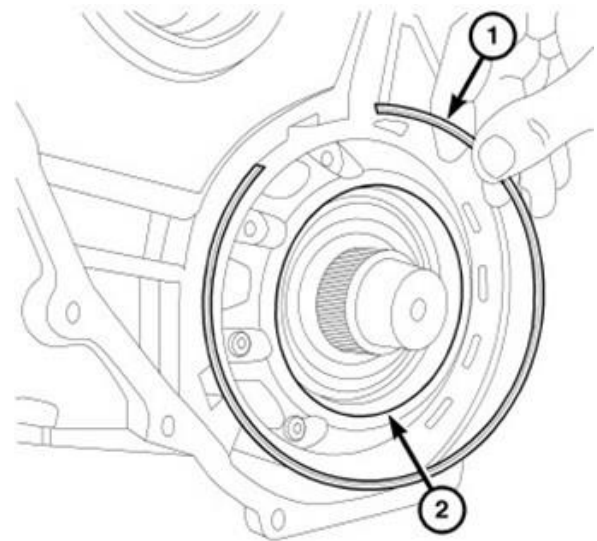
Figure 25 – Snap Ring

37. Remove and **DISCARD** the snap ring (1) at the underdrive compounder assembly (2) (Figure 25).

NOTE: A NEW snap ring will be used during assembly.

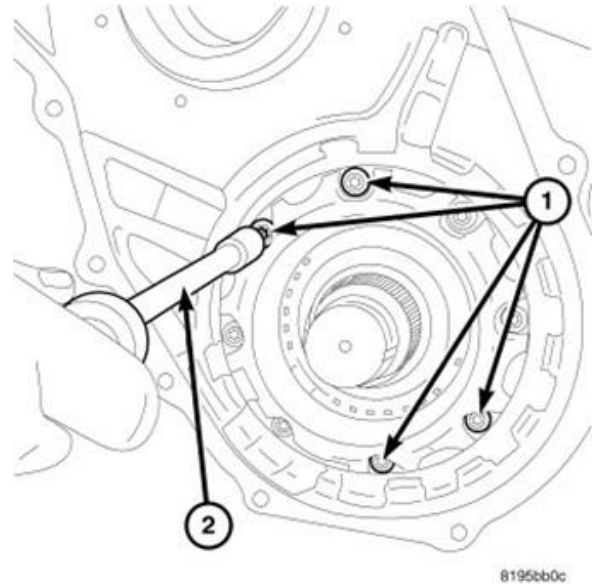
Figure 26 – Bearing Retainer Bolts

NOTE: The compounder bearing retainer bolts may be very tight so it is important to have a good fitting new driver tool (2) for removal of these bolts (1) or the bolts heads may become damaged during removal (Figure 26).

71. Remove the Puller Adapter 9908 (2) from the compounder bearing retainer (Figure 27).
72. Install all the remaining bolts (1) to the compounder bearing retainer then tighten all the bolts in a criss-cross pattern to 12 N·m (105 in. lbs.) (Figure 26).

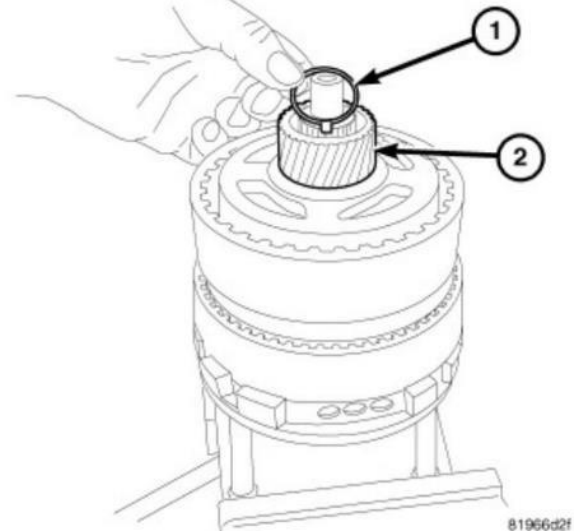
Figure 33 – Sun Gear Retaining Clip

47. **DISCARD** the retaining clip (1) that was removed from the transfer shaft (Figure 33).

NOTE: A NEW retaining clip will be used during assembly.

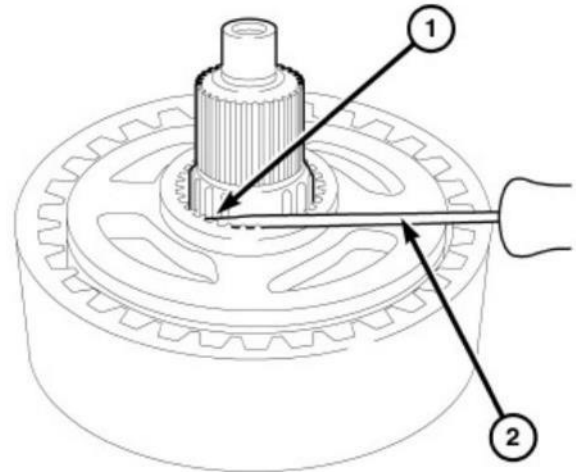
Figure 34 – Split Needle Bearing

49. Using a small pick (2) remove and **DISCARD** the split needle bearing (1) from transfer shaft (Figure 34).

NOTE: A NEW split needle bearing will be used during assembly.

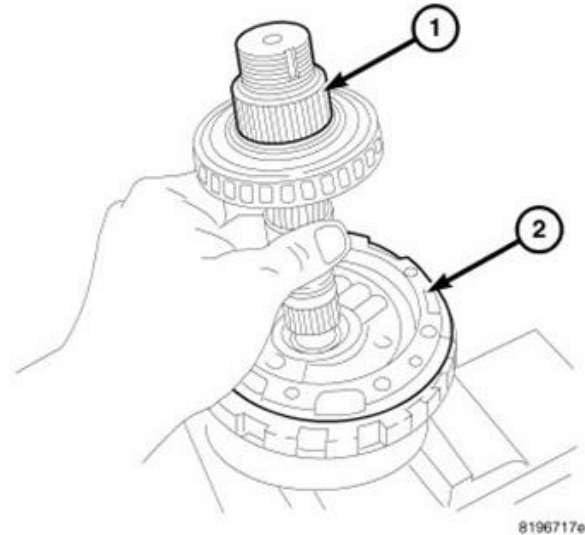
Figure 40 – Underdrive Shaft

56. Remove the underdrive shaft (1) from the low clutch (2) (Figure 40).
57. **DISCARD** the low clutch assembly (2) (Figure 40).
58. Obtain a **NEW** low clutch assembly (2) then reassemble compounder components in reverse order (Figure 40).
59. Install the underdrive shaft (1) to the lower clutch (2) (Figure 40).
60. Install the bearing retainer (2) to the lower clutch (3) (Figure 39).
61. Install four compounder bearing retainer screws leaving four screws out for installation of Puller Adapter 9908 (Figure 39).
