# SAFETY RECALL

## Park Engagement

Reference: 61A / NHTSA 23V-301

2019-2021 (VF) Ram ProMaster

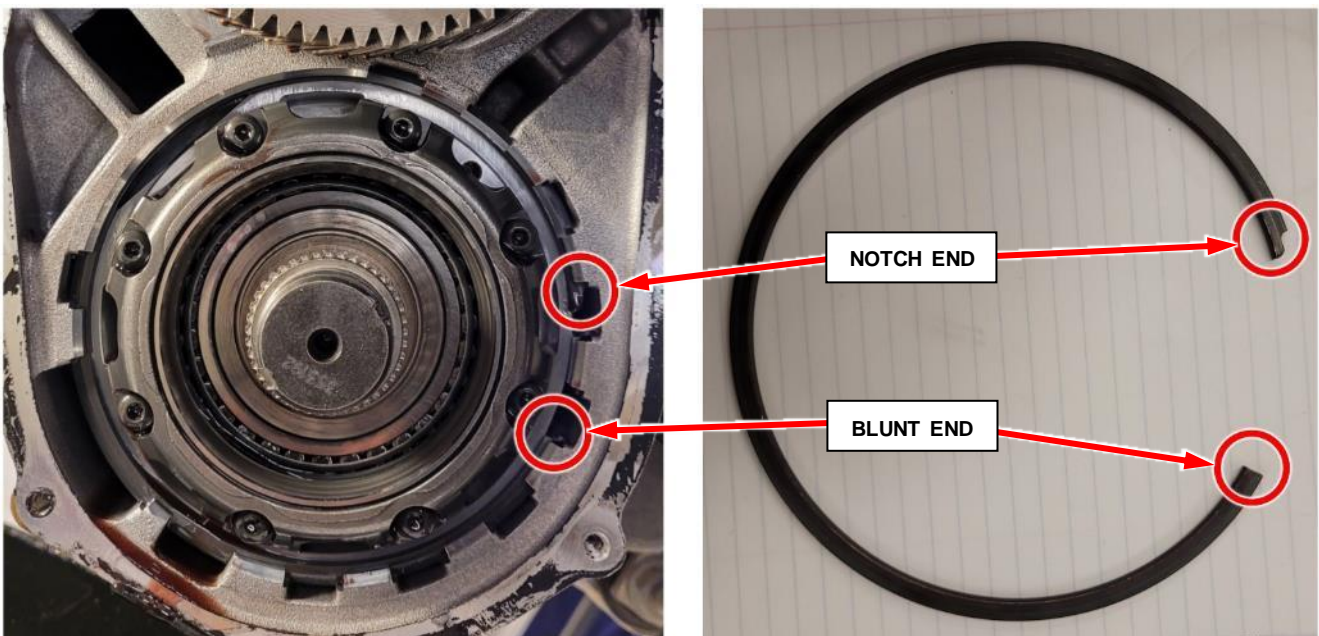
**Figure 42 – Snap Ring Installation Orientation**

**CAUTION: Snap ring is bevelled and MUST be installed in the proper orientation. When looking directly at the snap ring, the notch end and blunt ends must be oriented as shown regardless of clock position of snap ring when installed in the transmission. The snap ring ends should be oriented so that the ends are in an open space rather than in the snap ring groove (Figure 42).**

73. Obtain a **NEW** snap ring, then install that **NEW** snap ring to retain the underdrive compounder assembly. Ensure the snap ring is fully seated in the snap ring groove (Figure 42).
