RAM

Remedy available for
 2019-2021 (VF) Ram ProMaster

Park Engagement

Reference: 44A / NHTSA 23V-301

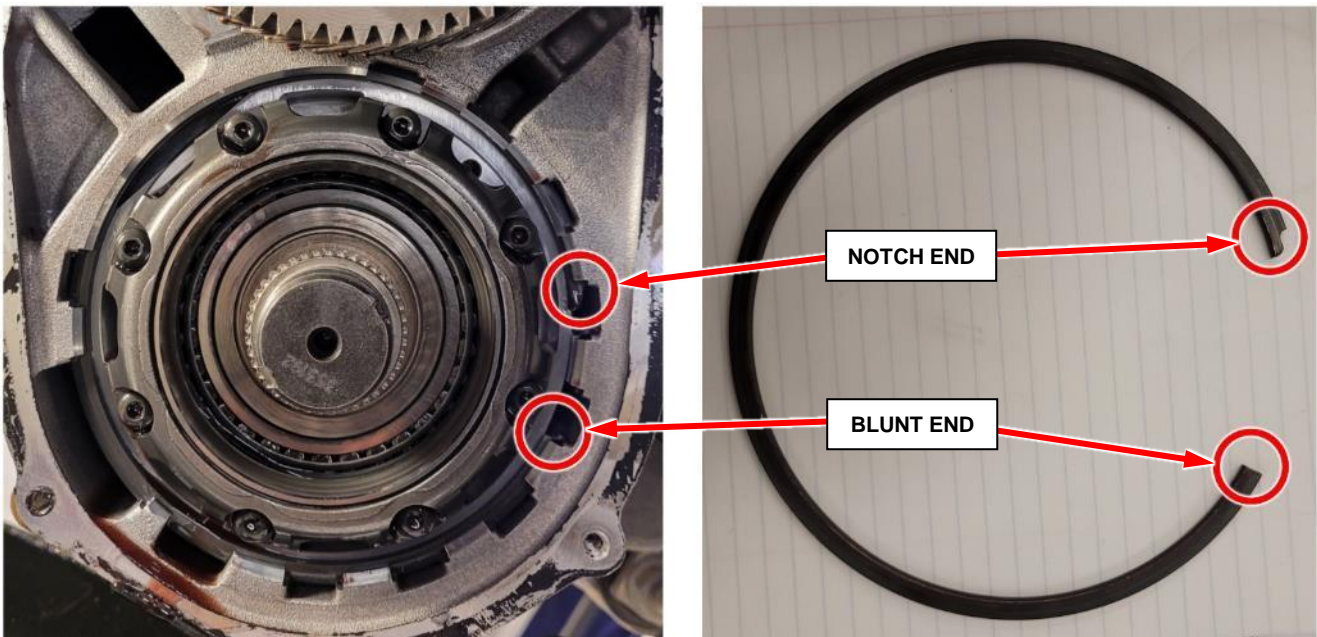
Figure 42 – Snap Ring Installation Orientation

CAUTION: Snap ring is bevelled and MUST be installed in the proper orientation. When looking directly at the snap ring, the notch end and blunt ends must be oriented as shown regardless of clock position of snap ring when installed in the transmission. The snap ring ends should be oriented so that the ends are in an open space rather than in the snap ring groove (Figure 42).

73. Obtain a **NEW** snap ring, then install that **NEW** snap ring to retain the underdrive compounder assembly. Ensure the snap ring is fully seated in the snap ring groove (Figure 42).
