# SAFETY RECALL

## Park Engagement

Reference: 44A / NHTSA 23V-301

2019-2021 (VF) Ram ProMaster

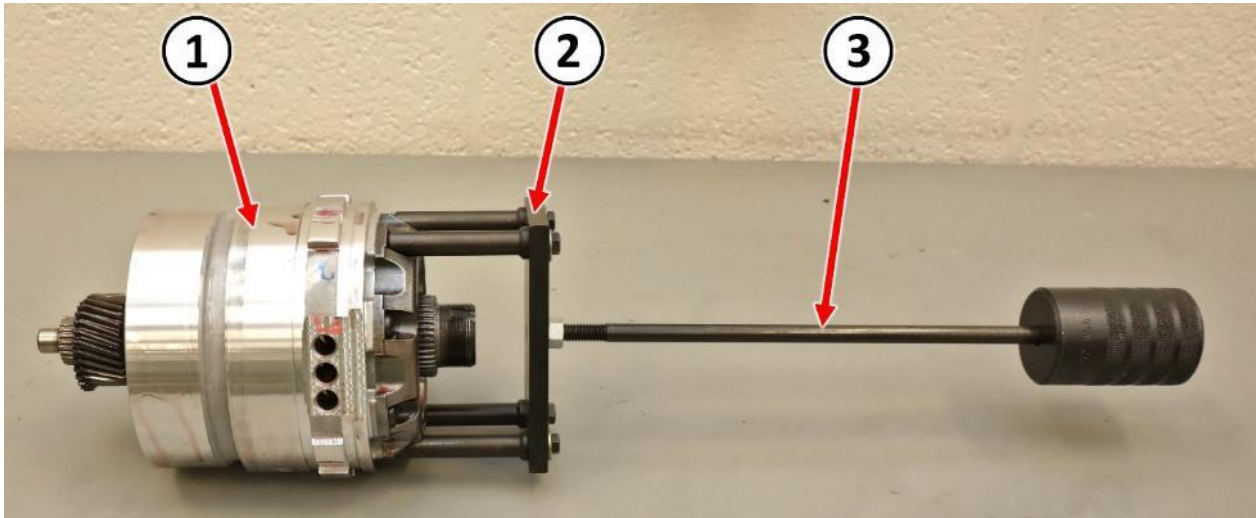
Figure 30 – Compounder Assembly on Clean Work Surface

42. Place the underdrive compounder assembly (1) on a clean work surface to prevent contamination (Figure 30).
