**RAM**

2019-2021 (VF) Ram ProMaster

## Park Engagement

Reference: 44A / NHTSA 23V-301

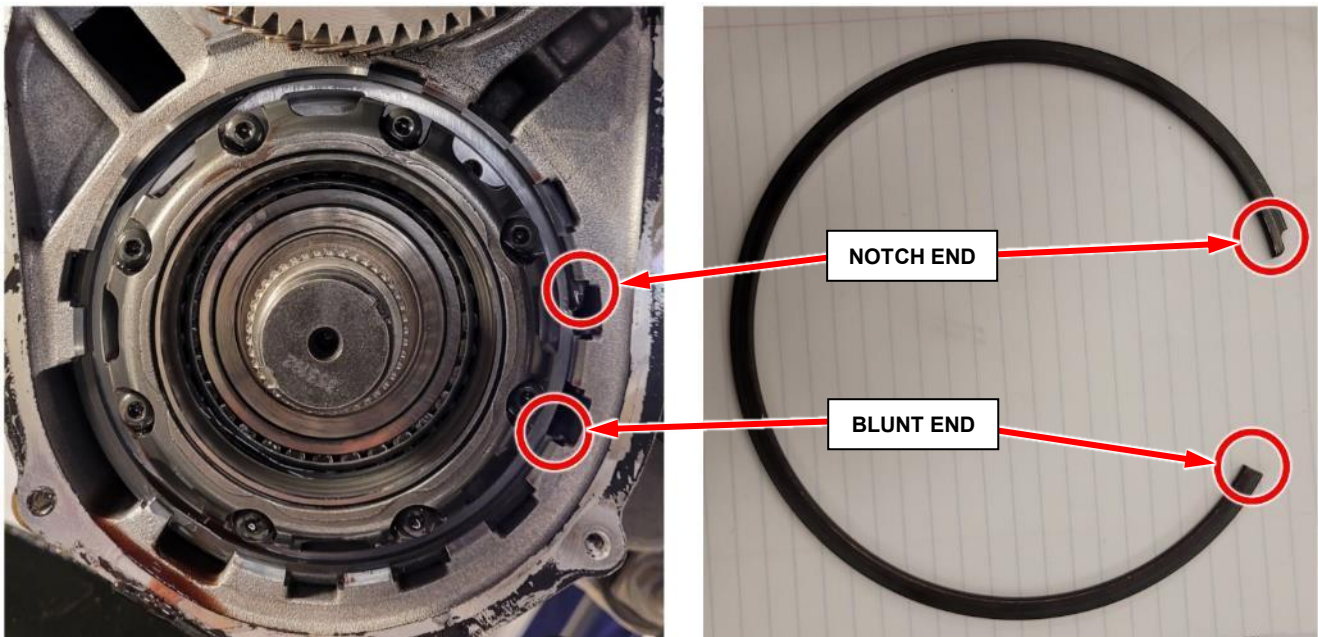
**Figure 42 – Snap Ring Installation Orientation**

**CAUTION: Snap ring is bevelled and MUST be installed in the proper orientation. When looking directly at the snap ring, the notch end and blunt ends must be oriented as shown regardless of clock position of snap ring when installed in the transmission. The snap ring ends should be oriented so that the ends are in an open space rather than in the snap ring groove (Figure 42).**

73. Obtain a **NEW** snap ring, then install that **NEW** snap ring to retain the underdrive compounder assembly. Ensure the snap ring is fully seated in the snap ring groove (Figure 42).
