RAM Remedy available for
 2019-2021 (VF) Ram ProMaster

Revision	Edition	Detail
2	July 2023	Section B Step 15 revised.

Park Engagement

Reference: 44A / NHTSA 23V-301

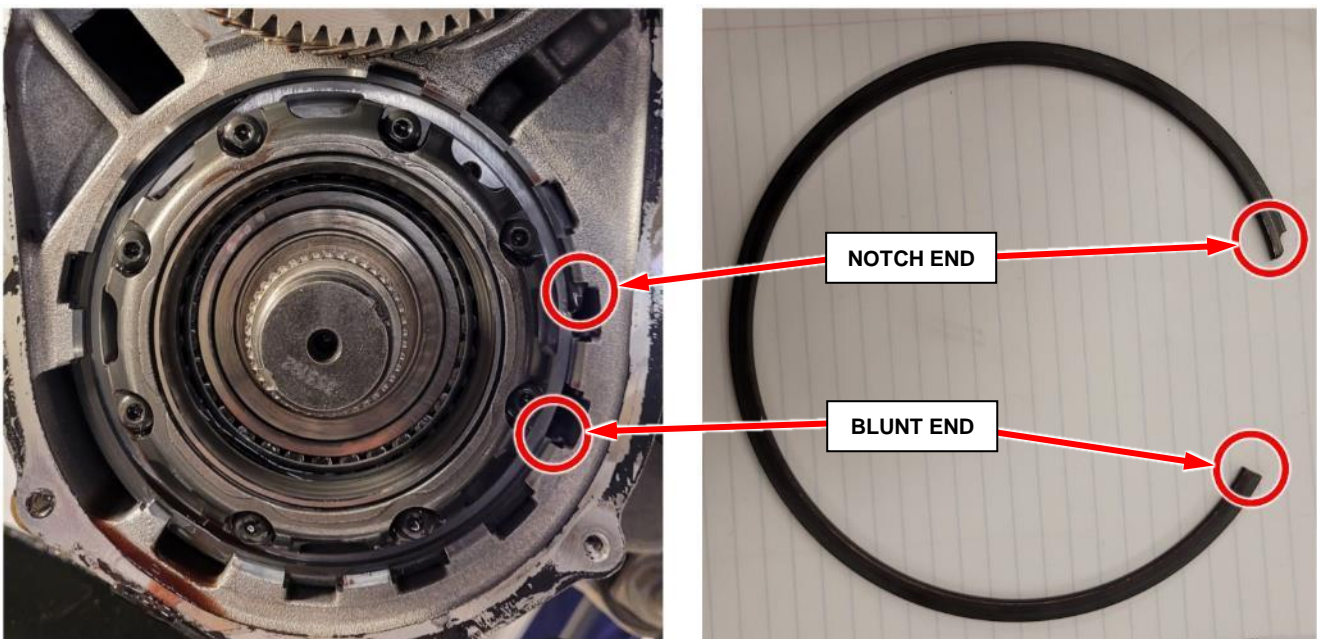
Figure 42 – Snap Ring Installation Orientation

CAUTION: Snap ring is bevelled and MUST be installed in the proper orientation. When looking directly at the snap ring, the notch end and blunt ends must be oriented as shown regardless of clock position of snap ring when installed in the transmission. The snap ring ends should be oriented so that the ends are in an open space rather than in the snap ring groove (Figure 42).

73. Obtain a **NEW** snap ring, then install that **NEW** snap ring to retain the underdrive compounder assembly. Ensure the snap ring is fully seated in the snap ring groove (Figure 42).
