SIM 61 05 23

RECALL 23V-337: FOOTWELL MODULE (FRM) MOISTURE/WATER INTRUSION

This Service Information Bulletin (Revision 6) replaces SI B61 05 23 **dated October 2024**.

BMW AG is conducting a Voluntary Safety Recall (effective May 11, 2023) on certain Model Year 2007 - 2014 MINI vehicles that were produced between November 16, 2006, and June 27, 2014.

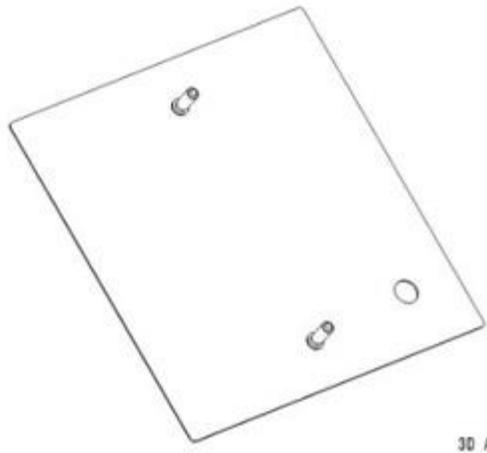
7275563

Floorboard Repair Procedure:

- Cut out the corroded edges of the hole(s)
- Using part number **(41 21 7 275 563 – Reinforcement plate universal)**, cut the replacement plate to the size of the current hole with an overlap of 2-3cm
- Remove the screws from the reinforcement plate if it is necessary to use the entire plate
- If the size of the reinforcement plate is not sufficient, a standard steel sheet (0.8-1mm thick) must be used
- Shape the panel in accordance with the contour of the floorboard
- Weld the reinforcement plate to the floorboard.
Make sure to review and follow the welding notes on the next slide
- Prime the repaired area using 2K epoxy primer
- Apply D1/D2 sealant to the repaired area

- Review and follow repair instructions 41 04 100 Handling electrical system and electronics
- Review and follow repair instructions 41 05 302- Welding and soldering steel components
- Screw any loose screws back in to protect the threads from welding spatter
- Cover the vehicle interior with welding blankets
- Ensure that the entire vehicle interior is protected with welding blankets and adhesive tape so that no welding spatter beads fall into any gaps or cavities
