Remedy available for  
 2021 - 2023 (WL) Jeep Grand Cherokee L  
 2022 - 2023 (WL) Jeep Grand Cherokee

# SAFETY RECALL

## Intermediate Shaft

Reference: 58A / NHTSA 23V-352

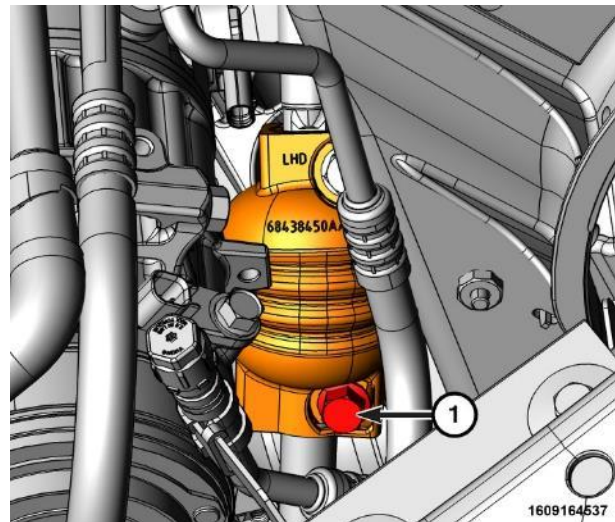
Figure 22 – U-Joint Coupling

- **Bolt Threads Damaged:** The U-Joint coupling will require replacement. Continue to **Step 6** of repair procedure.
- **Bolt Threads NOT Damaged:** U-Joint coupling may be reused. U-joint coupling replacement step may be skipped. Continue to **Step 7** of the repair procedure.

6. U-joint coupling replacement is **ONLY** necessary if bolt thread in previous step were damaged. If bolt threads were **NOT** damaged, skip this step for U-joint coupling replacement (Figure 22).

- a) Grasp the I-shaft near the U-joint coupling then slide the I-shaft back into itself releasing it from the U-joint coupling (Figure 23).
- b) Remove and **DISCARD** the lower steering column shaft coupling pinch bolt (1) (Figure 22).
- c) Remove and **DISCARD** the U-joint coupling from the steering gear shaft.
- d) Obtain a **NEW** U-joint coupling and install it to the steering gear shaft.
- e) Obtain a **NEW** pinch bolt and install it in the U-joint coupling lower hole (1) then tighten the bolt to 45 N·m (33 Ft. Lbs.) (Figure 22).
- f) Slide the I-shaft back into the U-joint coupling inserting the I-shaft fully into the U-joint coupling as far as it will go. The white plastic clip will act as a stop (Figure 23).
- g) Proceed to the next step of the repair procedure.
