Remedy available for
 2021 - 2023 (WL) Jeep Grand Cherokee L
 2022 - 2023 (WL) Jeep Grand Cherokee

SAFETY RECALL

Intermediate Shaft

Reference: 58A / NHTSA 23V-352

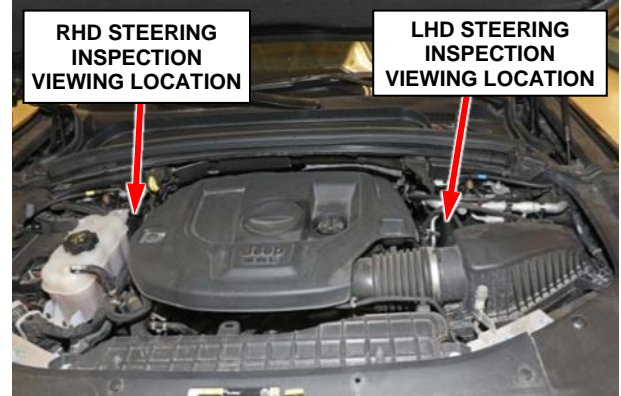
Figure 2 – Inspection Access Location

Inspection may be performed from under hood in engine compartment for vehicles equipped with the following (Figure 2):

- 3.6L Engine (Sales Code ERC) with RHD or LHD steering.
- 5.7L Engine (Sales Code EZH) with LHD steering.
- 2.0L Turbo Engine (Sales Code EC1) with RHD steering.

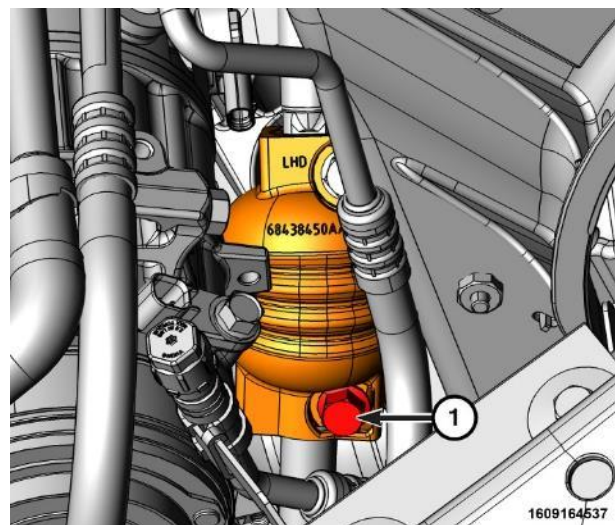
Figure 22 – U-Joint Coupling

6. U-joint coupling replacement is **ONLY** necessary if bolt thread in previous step were damaged. If bolt threads were **NOT** damaged, skip this step for U-joint coupling replacement (Figure 22).

- a) Grasp the I-shaft near the U-joint coupling then slide the I-shaft back into itself releasing it from the U-joint coupling (Figure 23).
- b) Remove and **DISCARD** the lower steering column shaft coupling pinch bolt (1) (Figure 22).
- c) Remove and **DISCARD** the U-joint coupling from the steering gear shaft.
- d) Obtain a **NEW** U-joint coupling and install it to the steering gear shaft.
- e) Obtain a **NEW** pinch bolt and install it in the U-joint coupling lower hole (1) then tighten the bolt to 45 N·m (33 Ft. Lbs.) (Figure 22).
- f) Slide the I-shaft back into the U-joint coupling inserting the I-shaft fully into the U-joint coupling as far as it will go. The white plastic clip will act as a stop (Figure 23).
- g) Proceed to the next step of the repair procedure.

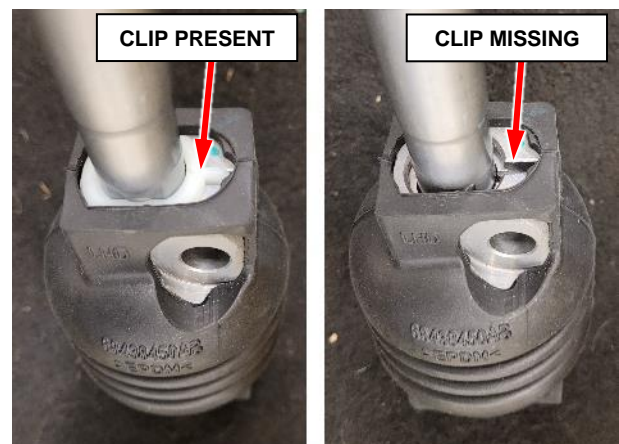
Figure 24 – White Plastic Clip

7. Is the white plastic clip present or missing from the U-joint coupling? (Figure 24)

- **White Plastic Clip Present:** Continue to next step of repair procedure.
- **White Plastic Clip Missing:** Obtain a **NEW** white plastic clip and follow these instructions.

- Grasp the I-shaft near the U-joint coupling then slide the I-shaft back into itself releasing it from the U-joint coupling (Figure 23).
- Install the white plastic clip to the U-joint coupling (Figure 24).
- Slide the I-shaft back into the U-joint coupling inserting the I-shaft fully into the U-joint coupling as far as it will go. The white plastic clip will act as a stop (Figure 23).
- Proceed to the next step of the repair procedure.
