PRODUCT CAMPAIGN BULLETIN

APPLICABILITY: 2023 Ascent

NUMBER: WRJ-23

SUBJECT: Lower Control Arm Castle Nut / Improper Torque

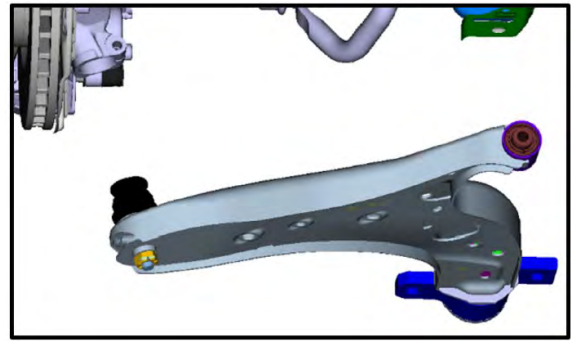
- The lower control arm assembly comes complete with the ball joint and control arm bushings previously installed as an assembly.

STEP 7: Replace the affected front lower control arm assembly as per the applicable Service Manual. Refer to STIS [Suspension > FRONT SUSPENSION > Front Arm](#)

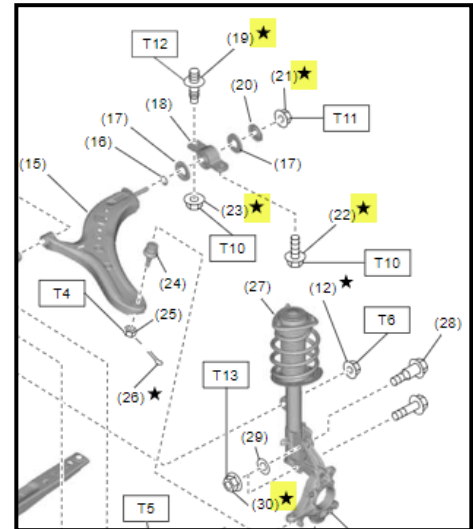
- **IMPORTANT:** The Service Manual uses a **black star (★)** in the component breakdown illustrations to indicate one-time use parts which **MUST** be replaced.
