SAFETY RECALL

Mack Trucks Inc.

Release Date	Number	Release	Page
06.2023	SC0444	01	1(3)

LRBE Electric Heater Relay Torque

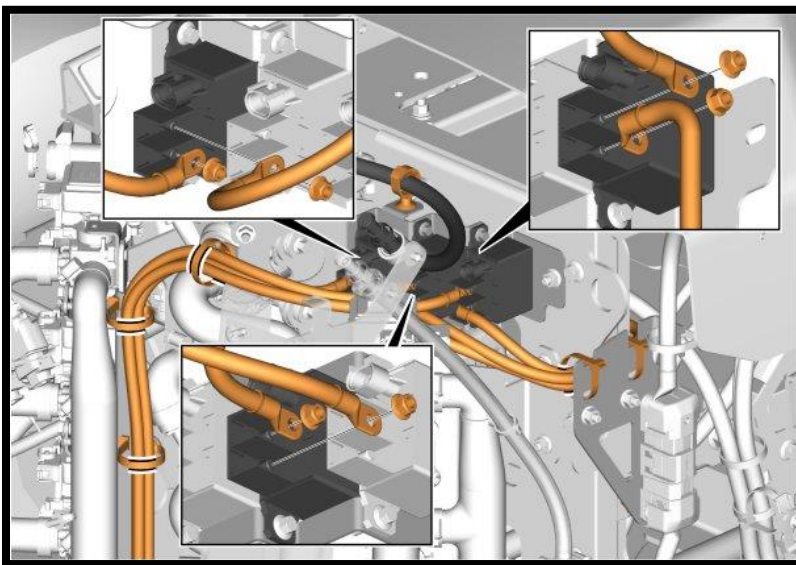
23. Inspect cable and mating surface to ensure and clean connection.

24. Reinstall relay power cables and nuts.

25. Torque relay power cable nuts to specification below.

Tightening torque	
Cable terminal, relay, nut	7.5 \pm 0.5 Nm (6 \pm 0.4 lb _r -ft)
