GROUP	MODEL
Safety Recall Campaign	2023MY Sportage (NQ5a)
NUMBER	DATE
SC272	June 2023

SUBJECT: **BRAKE BOOSTER INSPECTION & REPLACEMENT (SC272)**

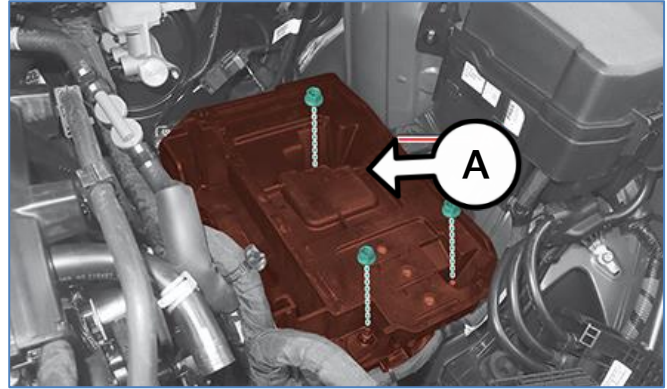
1. Open the hood.
2. Remove the battery tray (A) by referring to "Engine Electrical System → Charging System → Battery → Removal and Installation (Battery Tray)" in the applicable Shop Manual on KGIS.

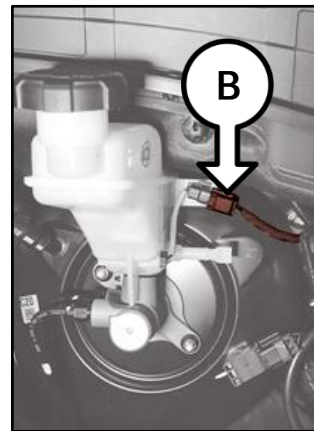
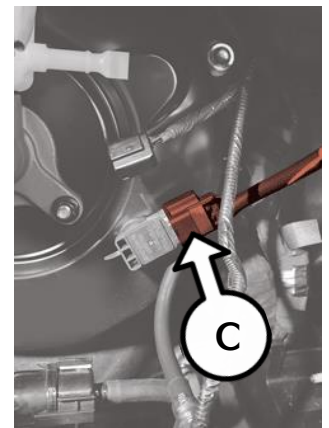
3. Disconnect the master cylinder brake fluid sensor connector (B).
4. Disconnect the brake booster vacuum sensor connector (C).

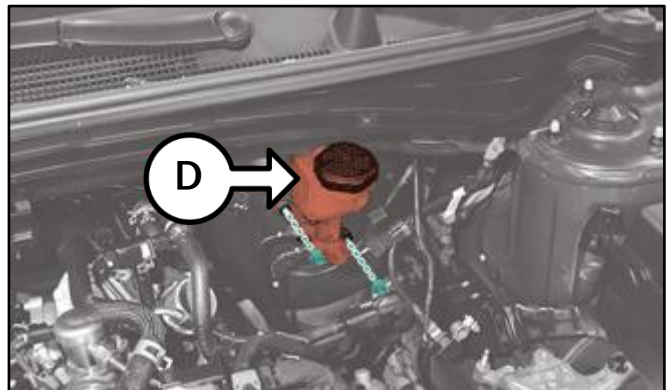
5. Detach the the brake master cylinder (D) by loosening the two (2) retaining bolts/screws.

Note: DO NOT disconnect the brake lines. This is a simplified method to allow removal of the brake booster.

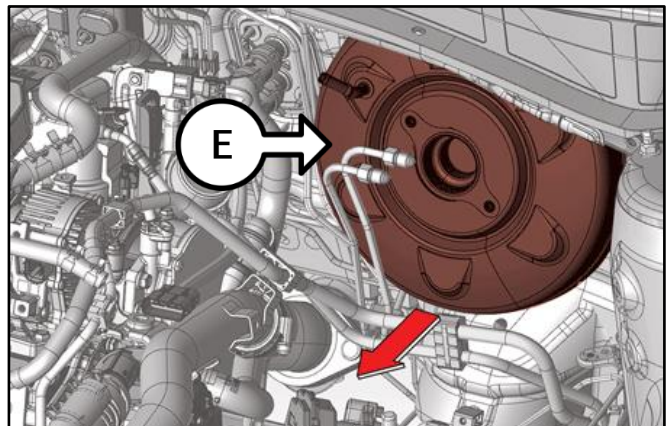
5. Remove the brake booster (E) by referring to "Brake System → Brake System → Brake Booster → Removal and Installation (from step 2)" in the applicable Shop Manual on KGIS.

Note: Image shown for reference use only. The master cylinder must remain attached to brake lines.

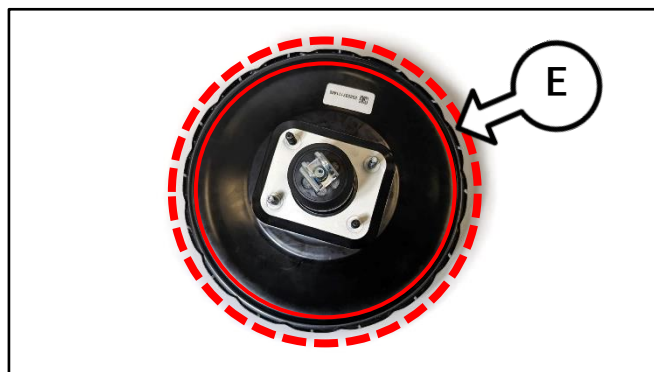
6. Using a feeler gauge, set a thickness of 0.75mm and place the brake booster (E) on a flat surface as shown.

7. Inspect the outer and inner shell gap between ALL gasket tab points (16 total), around the outer circumference area of the brake booster.

Note: The feeler gauge should not be able to be inserted between any check point of the inner and outer shell outlined area shown.

- 8a.
 - If the feeler gauge is able to be inserted between both of the shells with an excess gap of 0.75mm or more (**NG**), replace the brake booster assembly with a new part in the reverse order of removal.
