# VOLUNTARY RECALL CAMPAIGN

Classification: EL23-015	Reference: NTB23-050	Date: June 14, 2023
-----------------------------	-------------------------	------------------------

## VOLUNTARY SAFETY RECALL CAMPAIGN 2022 SENTRA; COWL SEAM SEAL

**CAMPAIGN ID #:** PMA21  
**APPLIED VEHICLES:** 2022 Sentra (B18)

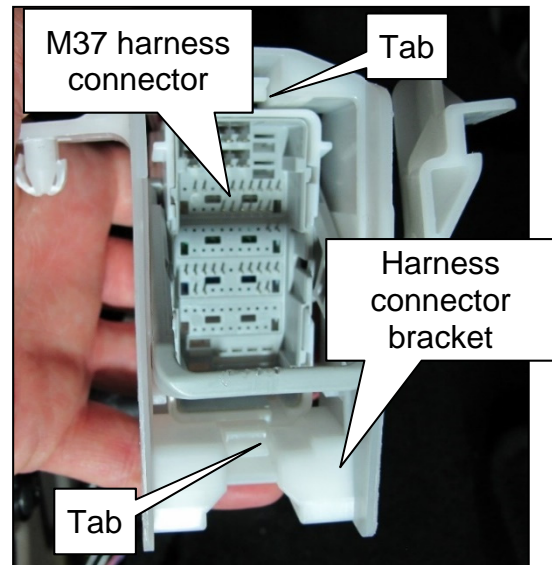
Figure 44

**IMPORTANT:** Step 35 is ONLY necessary if the harness connector bracket clips are broken during connector removal from the A pillar at step 28 on page 16.

35. Install a new harness connector bracket on the harness connector body.
  - a. Release the tabs at the top and bottom of the harness connector bracket.
  - b. Move the E7-M37 harness connector lock to the middle position.
  - c. With the tabs released, pull the harness connector bracket forward to remove it from the M37 harness connector.
  - d. Install the new harness connector bracket in reverse order of removal.
