December 18, 2024

## Safety Recall: 2018–23 Odyssey Install FAKRA Service Cables at MOST Bus Network

Supersedes 23-046, dated July 21, 2023, to the revise the information highlighted in **yellow**.

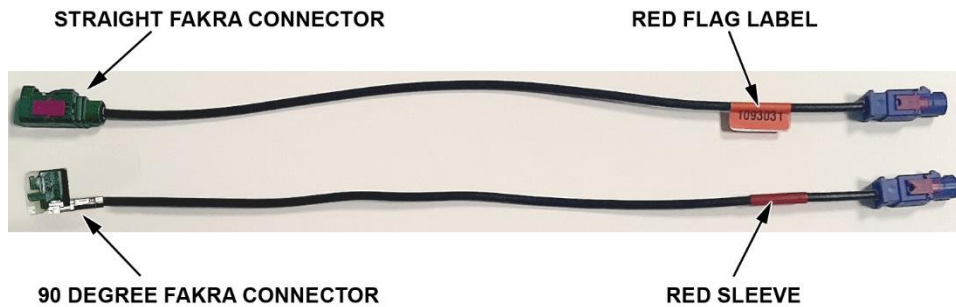
- **The splice box arrow must always point in the direction of either the red flag label or red sleeve on the FAKRA splice repair service cable.**
- If the splice box is installed **incorrectly**, the repair will fail; MOST ring failure conditions will still occur.
- Some vehicles may not apply the 90° FAKRA splice repair service cables.

1. Install the appropriate FAKRA splice repair service cables and splice boxes as shown in the steps that follow:

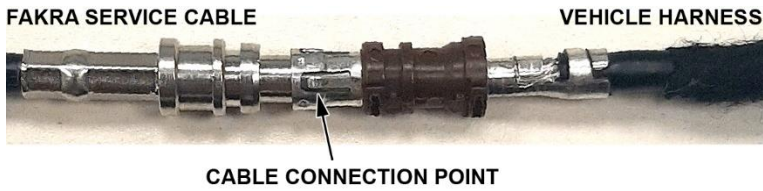
- Make sure the FAKRA service cable is inserted straight into the vehicle harness terminal to avoid damage at the cable connection point.
- Always disassemble the connectors one at a time to avoid swapping the green and red wires.

4. Connect the appropriate color FAKRA splice repair service cable to the vehicle harness.

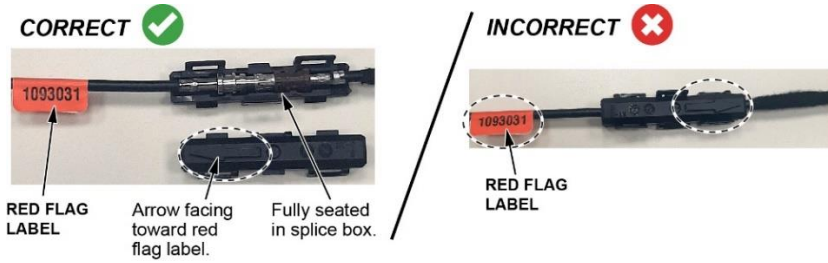
NOTE: Do not spin the splice box or the cables as this can cause damage to the connection point.

7. Make sure the arrow on the splice box **points** toward the red flag label or red sleeve.
