Safety Recall 23V-455

Claim Preparation & Repair Instructions

GREASE ZERK INSPECTION/CORRECTION PROCEDURE

Recall Number:	23E-046		
Product:	Grease Zerks		
Date:	July 10, 2023	Labor Rate:	Inspection - 0.3 hours per axle
			Repair - 0.3 hours per axle

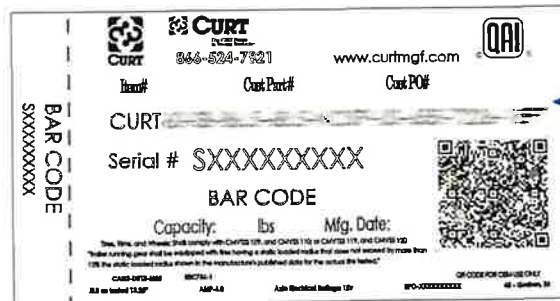
**Axle Tag Sample
(Not an exact replica)**

A clear photo of the axle tag, including the axle serial number, must be submitted once inspection or repair is completed.
