SAFETY RECALL

FRONT AXLE U-BOLT TORQUE

RECALL NO: AAUW0

REFERENCE: RCB-003-23

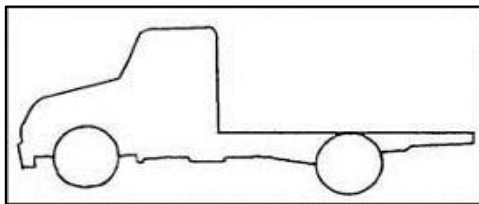
1. Park the vehicle on a level and solid surface. Confirm the engine is stopped, the starter switch is in the off (LOCK) position, and the key is removed.

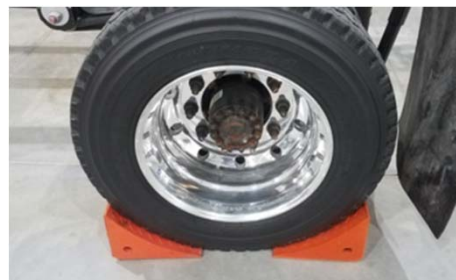
2. Apply the parking brake. Chock all of the wheels.
