TECHNICAL INSTRUCTIONS

SAFETY RECALL 23LA02

DRIVER AIRBAG MAY NOT DEPLOY

CERTAIN MODEL YEAR 2023-2024 NX AND 2023 RX

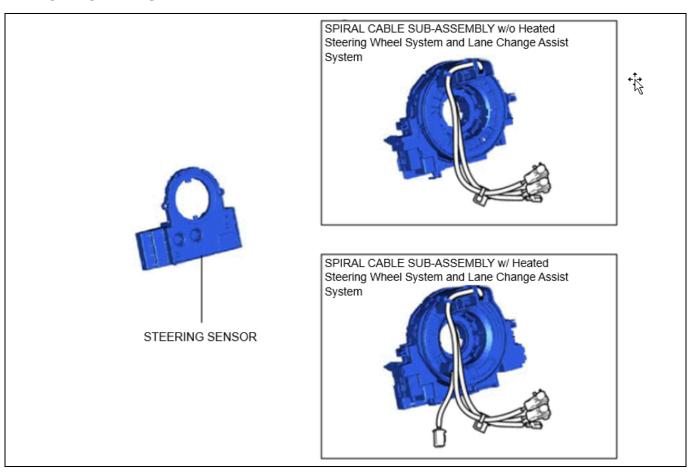
V. COMPONENTS

In the affected vehicles, the spiral cable assembly in the steering column may lose its electrical connection on the circuit controlling the driver's airbag. If this occurs, the airbag warning light will illuminate, and the driver's airbag may not deploy in a crash. As a result, the vehicle will not comply with certain federal motor vehicle safety requirements and may increase the risk of injury to the driver in the event of a crash.
