TITLE: 2023 NINJA[®] ZX[™]-4RR KRT EDITION ALTERNATOR ROTOR BOLT INSPECTION

RECALL

IMPORTANT SAFETY RECALL NHTSA RECALL NO. 23V-515

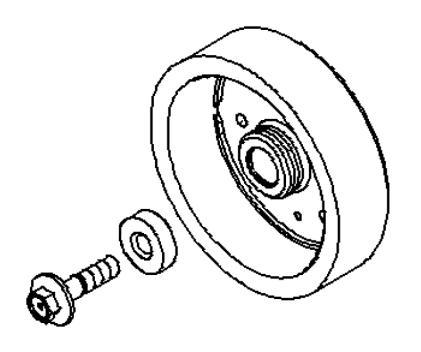
The alternator rotor could loosen and lead to an engine stall, increasing the risk of a crash.

Kawasaki has initiated a Recall campaign to inspect the rotor bolt for proper torque and correctly tighten bolts found to be improperly tightened.
