HYUNDAI Technical Service Bulletin	GROUP RECALL	NUMBER 23-01-071H-3
	DATE OCTOBER 2023	MODEL(S) PALISADE (LX2) SONATA (DN8) TUCSON (NX4) ELANTRA (CN7) KONA (OS)
SUBJECT: ELECTRIC OIL PUMP CONTROLLER INSPECTION AND REPLACEMENT (RECALL 246)

This TSB supersedes TSB # 23-01-071H-2 to add Elantra (CN7) and Kona (OS).

This bulletin provides the procedure to check the ISG Electric Oil Pump (EOP) controller specification and replace it if necessary.

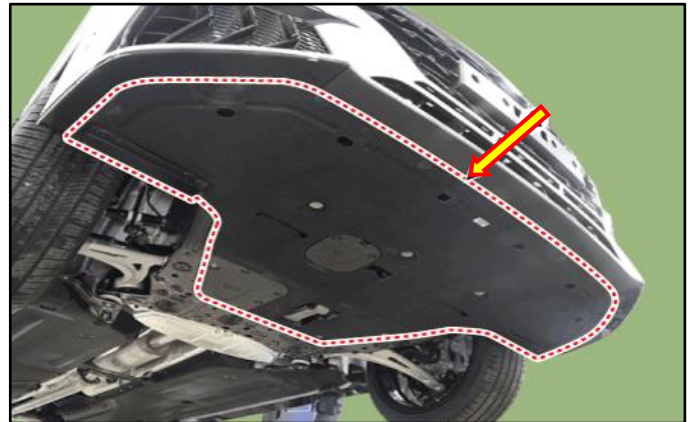
2. Check the EOP part number (A).

Use the part number on the part surface (A) as shown.

- If the part number is as follows, take a STUI picture as directed in step 3 below. Then reinstall the undercover and return the vehicle to the customer.
 - **46110-4G500**
 - **46110-4G510**
- If the part number is as follows, take a STUI picture as directed in step 3 below. Then continue to the Replacement Procedure to replace the EOP controller.
 - **46110-4G530**
