<b>HYUNDAI</b> <b>Technical Service Bulletin</b>	<b>GROUP</b> <b>RECALL</b>	<b>NUMBER</b> <b>24-01-015H</b>
	<b>DATE</b> <b>FEBRUARY 2024</b>	<b>MODEL(S)</b> <b>PALISADE (LX2)</b> <b>SONATA (DN8)</b> <b>TUCSON (NX4)</b> <b>ELANTRA (CN7)</b> <b>KONA (OS)</b>
<b>SUBJECT:</b> ELECTRIC OIL PUMP CONTROLLER INSPECTION AND REPLACEMENT (RECALL 246)

*This TSB supersedes TSB # 23-01-071H-3 to add a 'NOTICE' box on page 11, step 3 to remove the electric oil pump and housing as a single unit.*

**Description:** The transmission electric oil pump for the Idle Stop & Go System ("ISG") in certain vehicles listed below may have been assembled with printed circuit boards ("PCB") that were damaged during manufacturing by the oil pump controller supplier. A damaged capacitor on the pump controller PCB could impact electrical operation leading to heat damage to the electric oil pump circuit board, connector, and wiring harness. The heat damage at the pump increases the risk of a vehicle fire in addition to a potential Controller Area Network ("CAN") communication disruption for multiple onboard controllers.

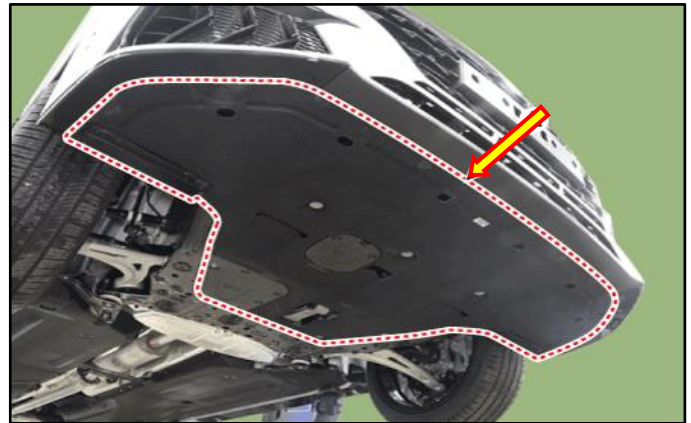
2. Check the EOP part number (A).

Use the part number on the part surface (A) as shown.

- If the part number is as follows, take a STUI picture as directed in step 3 below. Then reinstall the undercover and return the vehicle to the customer.
  - **46110-4G500**
  - **46110-4G510**
- If the part number is as follows, take a STUI picture as directed in step 3 below. Then continue to the Replacement Procedure to replace the EOP controller.
  - **46110-4G530**

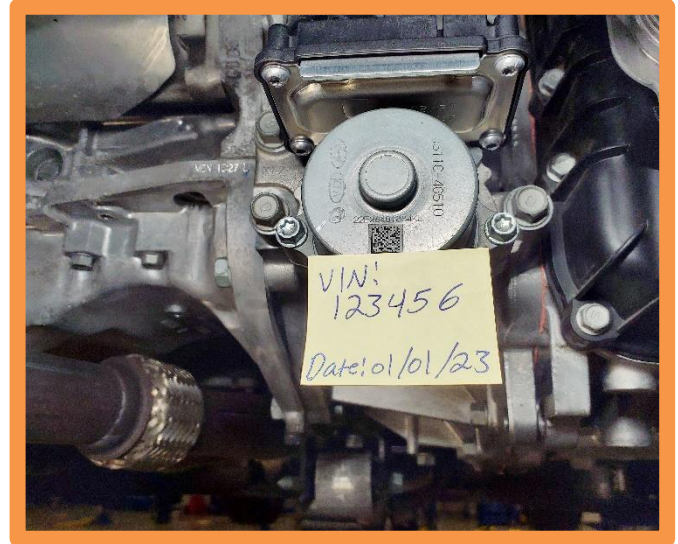
Using STUI, take a photo of the existing EOP with the part number visible, including the last 6 digits of the VIN and date of the inspection on a piece of paper.

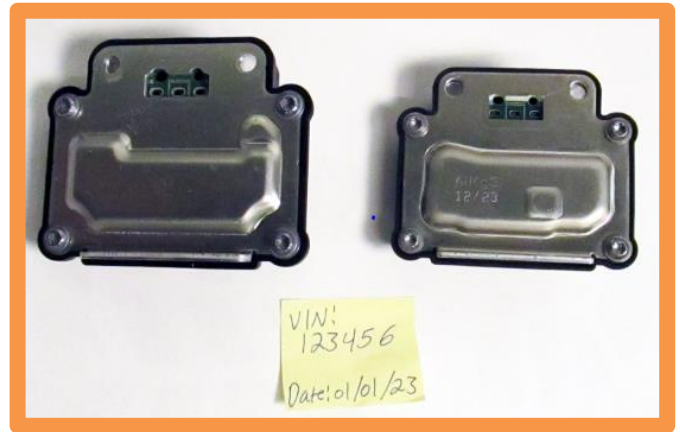
Using STUI, take a photo of the new controller (right) next to the existing controller (left) with the last 6 digits of the VIN and the date of the repair on a piece of paper.

4. Use a mirror to confirm the orange seal (D) is attached to the EOP.

Install the new controller.

Reinstall the bolts and torque to specification.  
**Torque: 6~7 lb-ft (8~10 N.m, 0.8~1.0 kgf.m)**

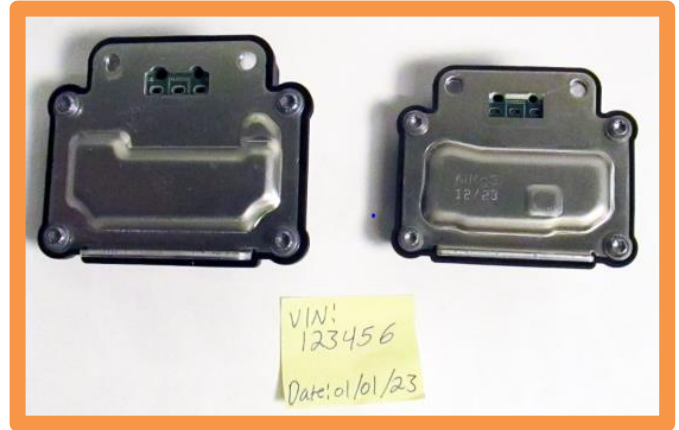
Using STUI, take a photo of the new controller (right) next to the existing controller (left) with the last 6 digits of the VIN and the date of the repair on a piece of paper.

8. Confirm the orange seal is correctly in place on the EOP.

Reinstall the new controller.

Reinstall 2 bolts and torque to specification.

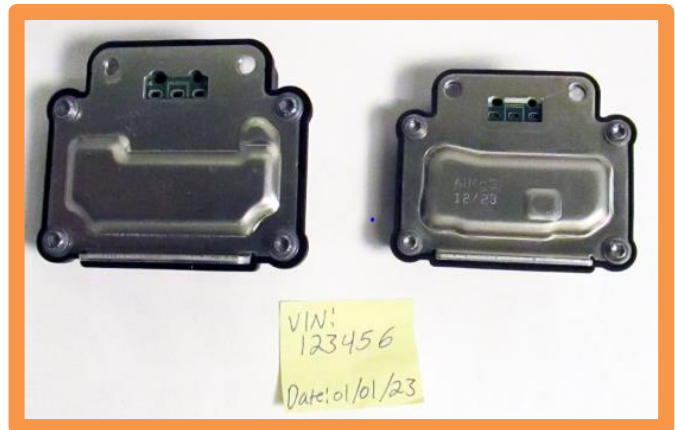
Using STUI, take a photo of the new controller (right) next to the existing controller (left) with the last 6 digits of the VIN and the date of the repair on a piece of paper.

6. Confirm the orange seal is attached to the EOP.
