HYUNDAI
Technical Service Bulletin

GROUP RECALL	NUMBER 23-01-071H-2
DATE SEPTEMBER 2023	MODEL(S) PALISADE (LX2) SONATA (DN8) TUCSON (NX4)

SUBJECT: ELECTRIC OIL PUMP CONTROLLER INSPECTION AND REPLACEMENT (RECALL 246)

This TSB supersedes TSB # 23-01-071H-1 to add 2024MY for the Tucson (NX4) & revise the applicable production dates for the Palisade (LX2) & Tucson.

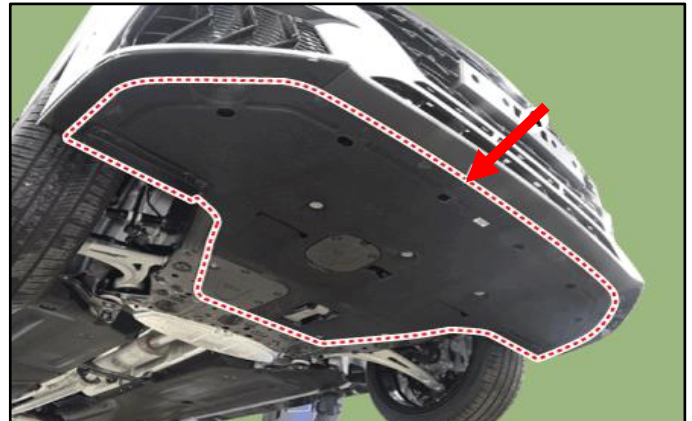
1. Record the preset radio stations.
Disconnect the negative (–) battery cable.
Lift the vehicle on a hoist and remove the undercover.
