# Safety Recall Code: 13i6

#### **Engine Connecting Rod**

Date	Summary			
09/29/2023	Added engine parts, claiming, and repair information.			
08/25/2023	Original publication

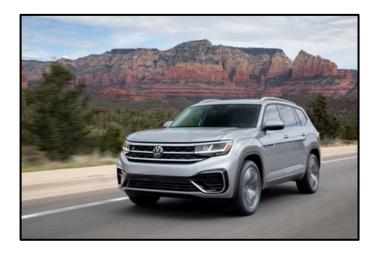
# Section B – Test Procedure: Oil Filter Replacement + Road Test (connecting rod stress test) + Oil Filter Inspection

- Remove oil filter.
- See examples of OK and NOT OK oil filter and housing on the following pages.
- If no excessive metal particles are found:
  - Engine does not require replacement.

- Replace oil filter and seal again.
  - o Torque housing to 25 Nm.
  - Proceed to Section D.
- If excessive metal particles are found:
  - o The engine requires replacement.
