# Safety Recall

## Code: 28H7

Subject Ignition Switch

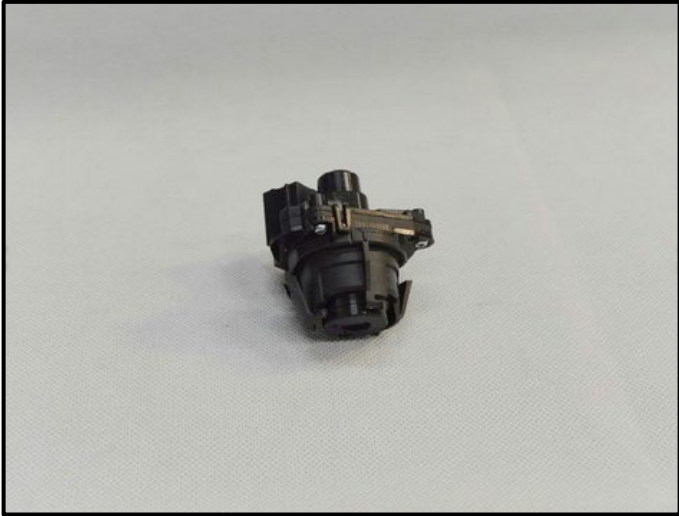
## Repair Overview

In vehicles equipped with a conventional ignition switch, the polyfuse can fail, particularly when the vehicle is operated in high temperature environments. If the polyfuse fails, it can result in the engine stalling while driving and failure of the vehicle's electrical system, increasing the risk of a crash.

- Replace ignition/starter switch.
