GROUP	MODEL
Noncompliance Safety Recall Campaign	2019MY Sorento (UMa)
NUMBER	DATE
SC282	March 2024

SUBJECT: **REAR VIEW CAMERA INSPECTION & REPLACEMENT (SC282)**

This bulletin provides information to inspect and, based on the inspection results, to replace the rearview camera or apply additional water proofing to the rearview camera on certain 2019MY Sorento (UMa) vehicles produced from August 1, 2018 through June 12, 2019. Due to an error in the manufacturing process, the rearview camera may be susceptible to water intrusion. If water enters the rear of the camera, the camera's image may become blank while in reverse. As a result, the subject vehicles fail to comply with the rear visibility requirement of the Federal Motor Vehicles Safety Standard (FMVSS) 111, ('Rear Visibility'). A rearview camera that does not display what is behind the vehicle increases the risk of a crash. Follow the procedure outlined in this publication to inspect and, if necessary, replace the rearview camera on the applicable vehicle. If no issue is found following inspection, dealers will apply additional water proofing to the camera wiring harness. Before conducting the procedure, verify that the vehic

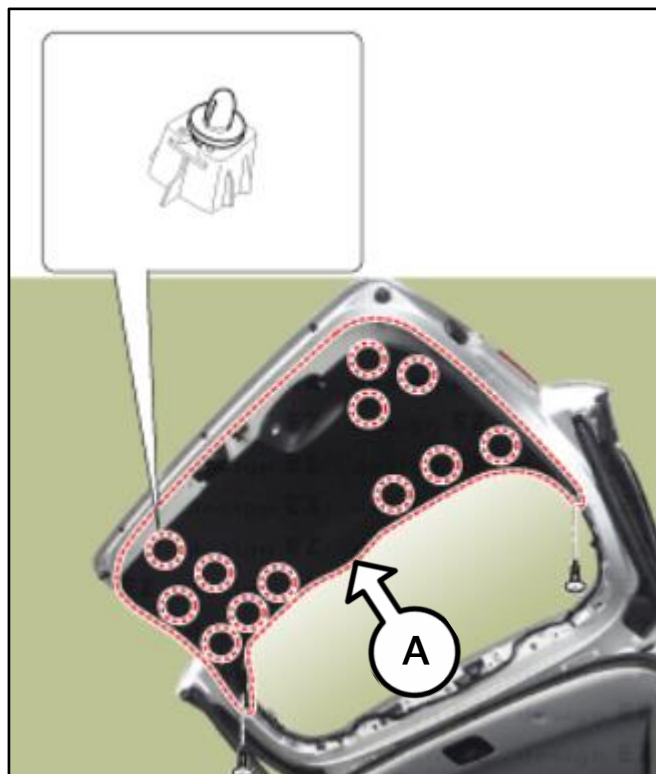
2. Remove the tailgate trim (A) by referring to "Body (Interior and Exterior) → Tail Gate → Tail Gate Trim → Repair procedures" in the applicable Shop Manual on KGIS.

Note: Replace any broken clips during removal (PN 87382 2W000QQK)

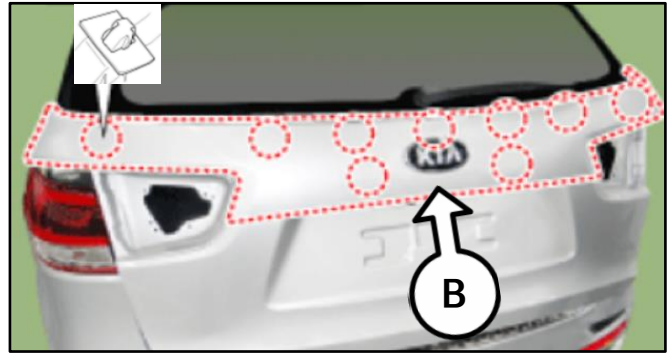
- Remove the tailgate back panel (B) by referring to "Body (Interior and Exterior) → Tail Gate → Tail Gate Trim → Repair procedures" in the applicable Shop Manual on KGIS.

Note: Replace any broken clips during removal (PN 82315 2P000QQK)

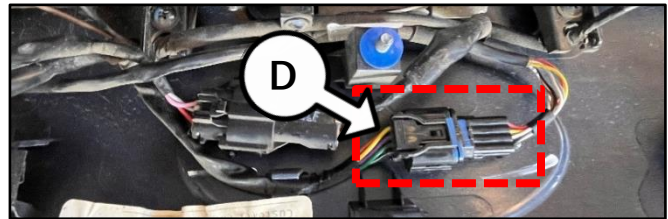
- Disconnect the rear view camera connector (D).

- Using the multimeter (SST DT-830D), measure the resistance between; PIN 1 & PIN 4 and PIN 1 & PIN 2.

- If **no** resistance is found 'O.L.' (OK), proceed to the 'Repair Procedure' on page 5.
- If resistance **is** found (NG), proceed to 'Replacement Procedure' on page 6.
