GROUP	MODEL
Noncompliance Safety Recall Campaign	2019MY Sorento (UMa)
NUMBER	DATE
SC282 (Rev 1, 04/04/2024)	March 2024

SUBJECT: **REARVIEW CAMERA INSPECTION & REPLACEMENT (SC282)**

This bulletin provides information to inspect and, based on the inspection results, to replace the rearview camera or apply additional water proofing to the rearview camera on certain 2019MY Sorento (UMa) vehicles produced from August 1, 2018 through June 12, 2019. Due to an error in the manufacturing process, the rearview camera may be susceptible to water intrusion. If water enters the rear of the camera, the camera's image may become blank while in reverse. As a result, the subject vehicles fail to comply with the rear visibility requirement of the Federal Motor Vehicles Safety Standard (FMVSS) 111, ('Rear Visibility'). A rearview camera that does not display what is behind the vehicle increases the risk of a crash. Follow the procedure outlined in this publication to inspect and, if necessary, replace the rearview camera on the applicable vehicle. If no issue is found following inspection, dealers will apply additional water proofing to the camera wiring harness. Before conducting the procedure, ve

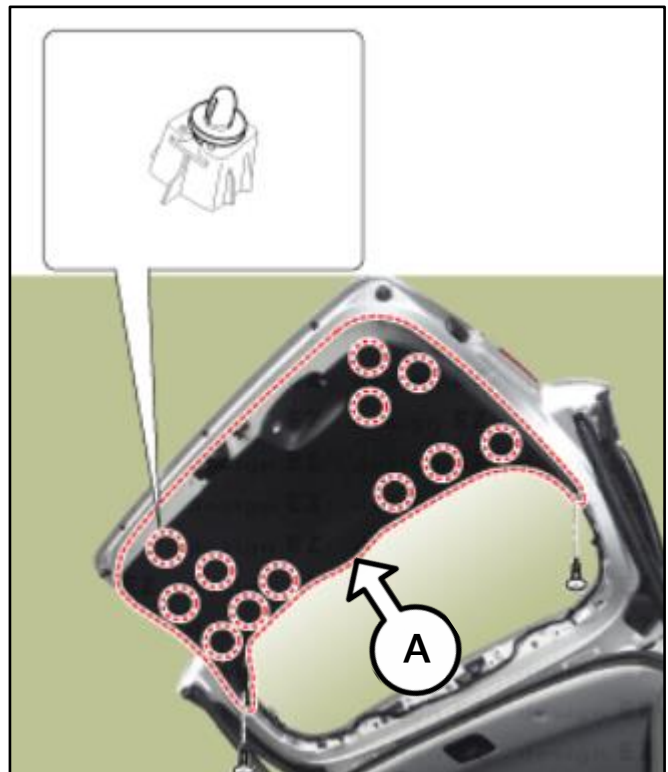
2. Remove the tailgate trim (A) by referring to "Body (Interior and Exterior) → Tail Gate → Tail Gate Trim → Repair procedures" in the applicable Shop Manual on KGIS.

Note: Replace any broken clips during removal (PN 82315 2P000QQK)

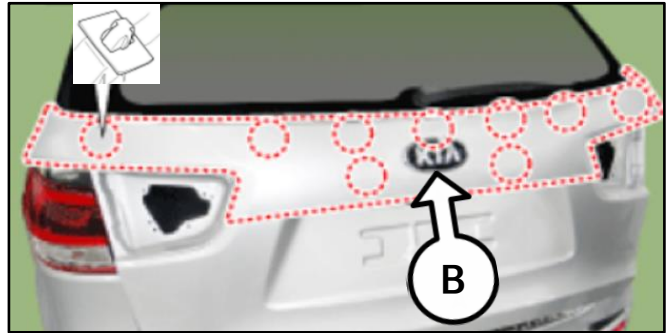
- Remove the tailgate back panel (B) by referring to “Body (Interior and Exterior) → Tail Gate → Tail Gate Trim → Repair procedures” in the applicable Shop Manual on KGIS.

Note: Replace any broken clips during removal (PN 87382 2W000QQK)

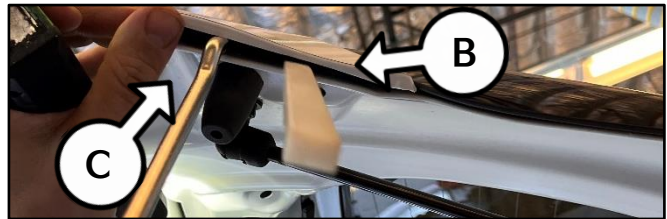
Note: Use a non-marring trim removal tool to create a space between the tail gate (C) and the tail gate back panel (B). Use another non-marring trim removal tool to disengage the clips.

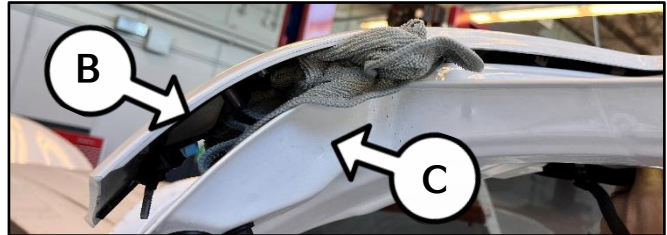
Note: Place a rag between tail gate (C) and the tail gate back panel (B) to act as a wedge while disengaging the remaining clips.
