GROUP	MODEL
Noncompliance Safety Recall Campaign	2019MY Sorento (UMa)
NUMBER	DATE
SC282 (Rev 2, 05/15/2024)	March 2024

SUBJECT: **REARVIEW CAMERA INSPECTION & REPLACEMENT (SC282)**

This bulletin provides information to inspect and, based on the inspection results, to replace the rearview camera or apply additional water proofing to the rearview camera on certain 2019MY Sorento (UMa) vehicles produced from August 1, 2018 through June 12, 2019. Due to an error in the manufacturing process, the rearview camera may be susceptible to water intrusion. If water enters the rear of the camera, the camera's image may become blank while in reverse. As a result, the subject vehicles fail to comply with the rear visibility requirement of the Federal Motor Vehicles Safety Standard (FMVSS) 111, ('Rear Visibility'). A rearview camera that does not display what is behind the vehicle increases the risk of a crash. Follow the procedure outlined in this publication to inspect and, if necessary, replace the rearview camera on the applicable vehicle. If no issue is found following inspection, dealers will apply additional water proofing to the camera wiring harness. Before conducting the procedure, ve

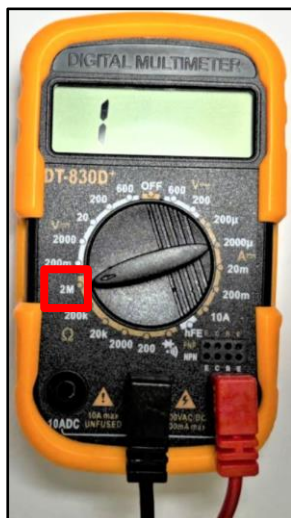
Measurement (after 10 seconds)	Result
'1' (on the left)	OK
LESS than 2MΩ	NG

Measurement (after 10 seconds)	Result
O.L / O.F	OK
Greater than or equal to 2MΩ	OK
LESS than 2MΩ	NG

When using SST DT-830D (displayed on the left), the O.L / O.F condition may also be displayed as '1'. Ensure the range is set to 2MΩ.

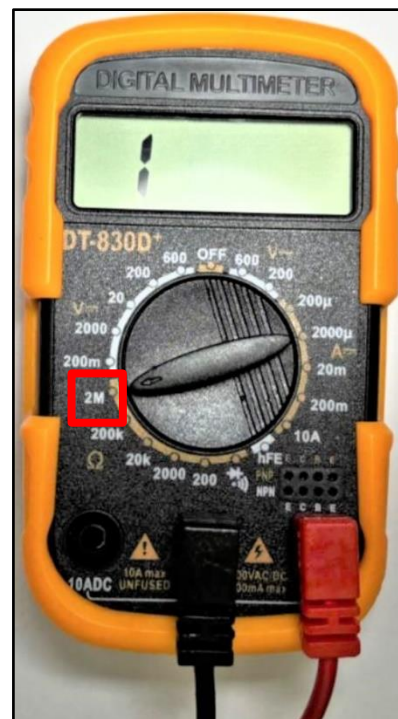
Rear Camera

- PIN 1 (Red) & PIN 4 (Black)
- PIN 1 (Red) & PIN 2 (Yellow)

- If the resistance reading is greater than or equal to 2MΩ or 'O.L / O.F' (OK), proceed to the 'Repair Procedure' on page 6.
- If the resistance found is less than 2MΩ (NG), record a KVID video starting from the VIN label on the door and then show the meter reading, then proceed to 'Replacement Procedure' on page 7.
