HYUNDAI
Technical Service Bulletin

| GROUP RECALL | NUMBER 24-01-027H-9 |

SUBJECT: ANTI-LOCK BRAKING SYSTEM (ABS) FUSE REPLACEMENT
 (RECALL 251)

This TSB supersedes TSB#24-01-027H-8 to revise the starting production date ranges for Tucson (LM) and Veracruz (EN) models.

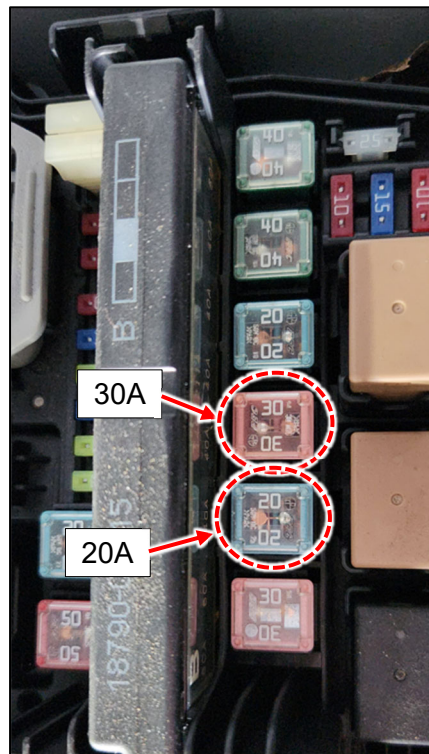
Fuse values shown are for Sonata Hybrid (YF HEV). Refer to the Single Fuse Table for the specific model fuse locations and values.

- Install the two new single fuses as shown.

ESC1 position (40A fuse originally)
Install new 30A fuse (pink).

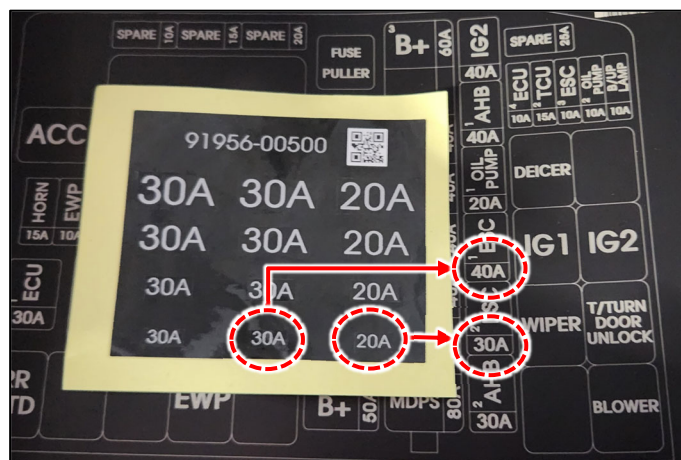
Fuse values shown are for Sonata Hybrid (YF HEV). Refer to the Single Fuse Table for the specific model fuse locations and values.

- Select the appropriately sized labels with the corresponding amperage values for the two fuses installed.

Clean the surface, then attach the supplied labels to the junction box cover as shown.

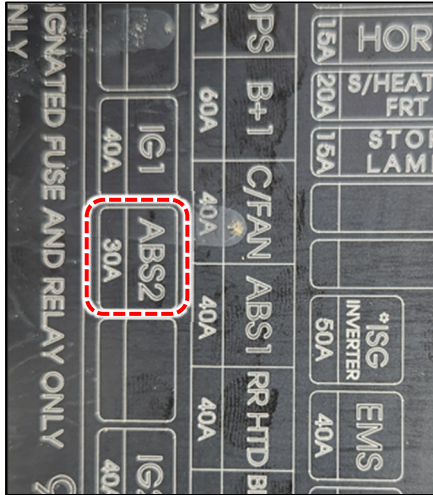
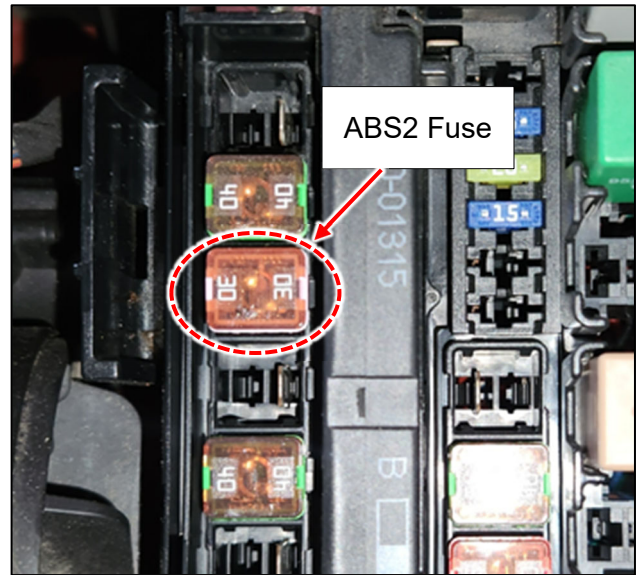
Single fuse shown is for Elantra Coupe (JK). Refer to the Single & Multi-Fuse Table for the specific model single fuse location.

4. For Elantra (MD/UD), Elantra Coupe (JK), and Azera (HG) vehicles:
 Locate the ABS2/ESC2 single fuse. Remove the fuse.

For Veloster (FS) vehicles:
 Locate the ABS1 single fuse. Remove the fuse.

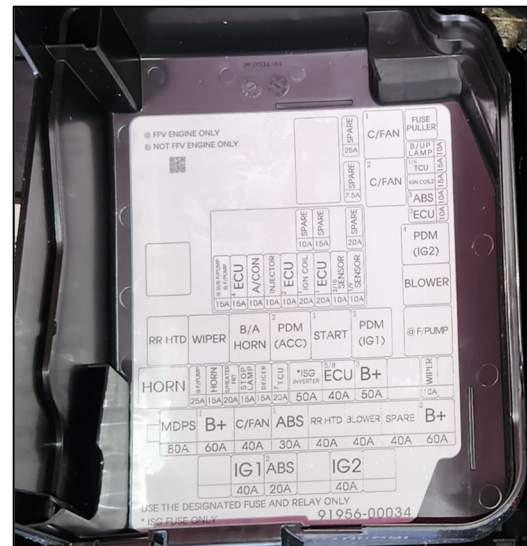
Fuse label shown is for Elantra Coupe (JK). Refer to the Single & Multi-Fuse Table for the specific model fuse value changes.

For Veloster (FS) ABS2 fuse location, the supplied 20A label may slightly exceed the boundary printed on the original fuse cover.
