HYUNDAI
Technical Service Bulletin

GROUP RECALL	NUMBER 24-01-027H-2
DATE MAY 2024	MODEL(S) SEE APPLICABLE MODEL LIST

SUBJECT: ANTI-LOCK BRAKING SYSTEM (ABS) FUSE REPLACEMENT
 (RECALL 251)

This TSB supersedes TSB#24-01-027H-1 to add Accent (RB) and Santa Fe (NC) models.

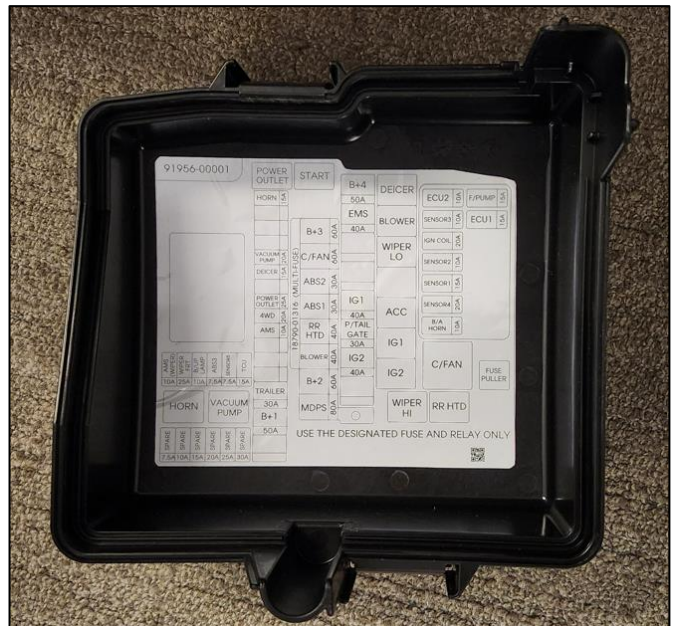
Fuse label shown is for Santa Fe Sport (AN). Refer to the Multi-Fuse Table for the specific model fuse value changes.

5a. For Santa Fe Sport (AN) and Santa Fe (NC) vehicles:

Clean the surface, then attach the supplied label to the new upper cover.

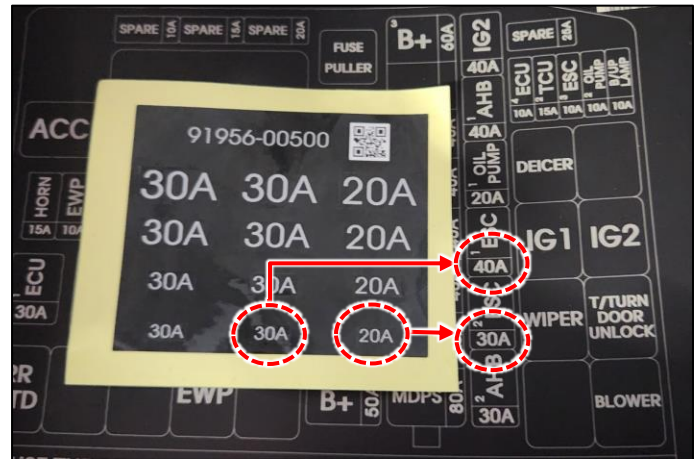
Fuse values shown are for Sonata Hybrid (YF HEV). Refer to the Single Fuse Table for the specific model fuse locations and values.

- Select the appropriately sized labels with the corresponding amperage values for the two fuses installed.

Clean the surface, then attach the supplied labels to the junction box cover as shown.
