HYUNDAI
Technical Service Bulletin

GROUP RECALL	NUMBER 24-01-027H-4
DATE MAY 2024	MODEL(S) SEE APPLICABLE MODEL LIST

SUBJECT: ANTI-LOCK BRAKING SYSTEM (ABS) FUSE REPLACEMENT
 (RECALL 251)

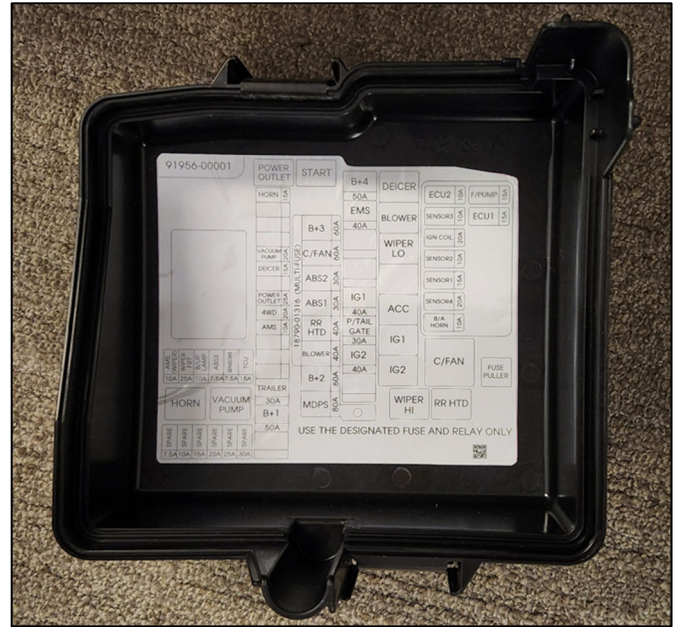
Fuse label shown is for Santa Fe Sport (AN). Refer to the Multi-Fuse Table for the specific model fuse value changes.

- 5a. For Santa Fe Sport (AN), Santa Fe (NC), and Tucson (LM) vehicles:

Clean the surface, then attach the supplied label to the new upper cover.

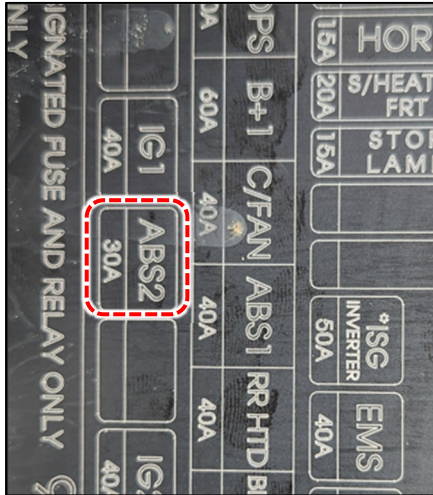
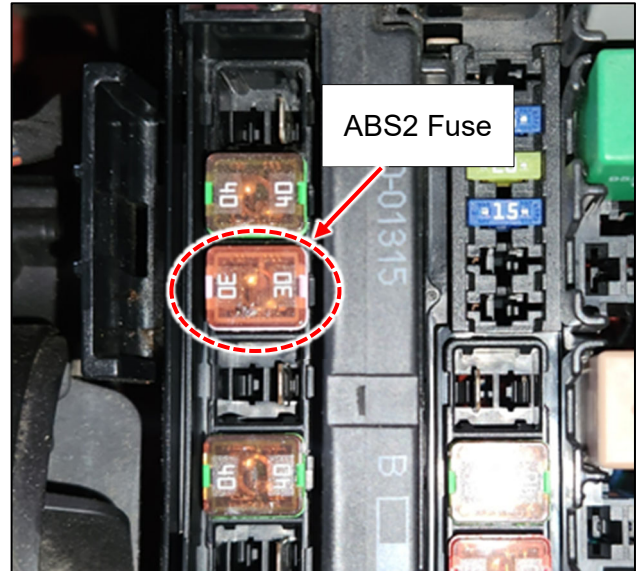
Single fuse shown is for Elantra Coupe (JK). Refer to the Single & Multi-Fuse Table for the specific model single fuse location.

4. Locate the ABS2 single fuse. Remove the fuse.

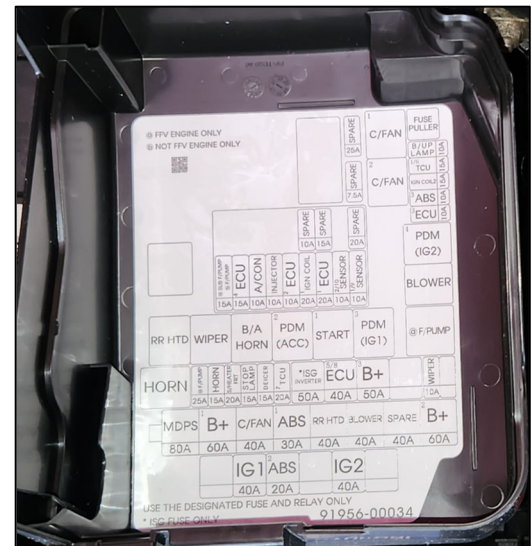
Fuse label shown is for Elantra Coupe (JK). Refer to the Single & Multi-Fuse Table for the specific model fuse value changes.

7. Clean the surface, then attach the supplied label to the new upper cover.
