**HYUNDAI**  
**Technical Service Bulletin**

GROUP <b>RECALL</b>	NUMBER <b>24-01-027H-7</b>
DATE <b>JUNE 2024</b>	MODEL(S) <b>SEE APPLICABLE MODEL LIST</b>

**SUBJECT:** ANTI-LOCK BRAKING SYSTEM (ABS) FUSE REPLACEMENT  
 (RECALL 251)

This TSB supersedes TSB#24-01-027H-6 to add 2011-2015MY Genesis Coupe (BK).

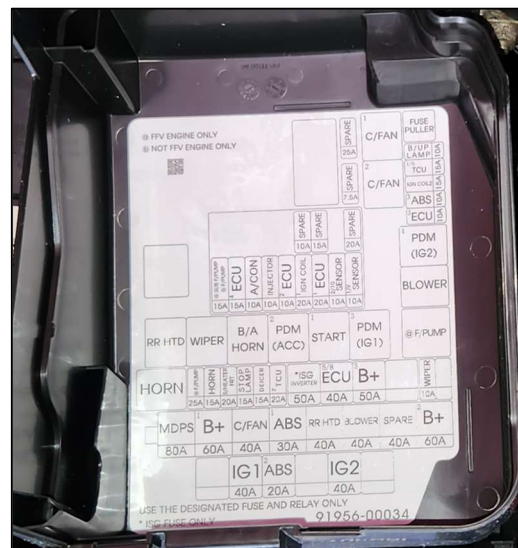
For Veloster (FS) ABS2 fuse location, the supplied 20A label may slightly exceed the boundary printed on the original fuse cover.

7. For Elantra (MD/UD), Elantra Coupe (JK), and Azera (HG) vehicles:

Clean the surface, then attach the supplied label to the new upper cover.
