HYUNDAI
Technical Service Bulletin

GROUP RECALL	NUMBER 24-01-027H-6
DATE JUNE 2024	MODEL(S) SEE APPLICABLE MODEL LIST

SUBJECT: ANTI-LOCK BRAKING SYSTEM (ABS) FUSE REPLACEMENT
 (RECALL 251)

This TSB supersedes TSB#24-01-027H-5 to add 2012-2015MY Veloster (FS).

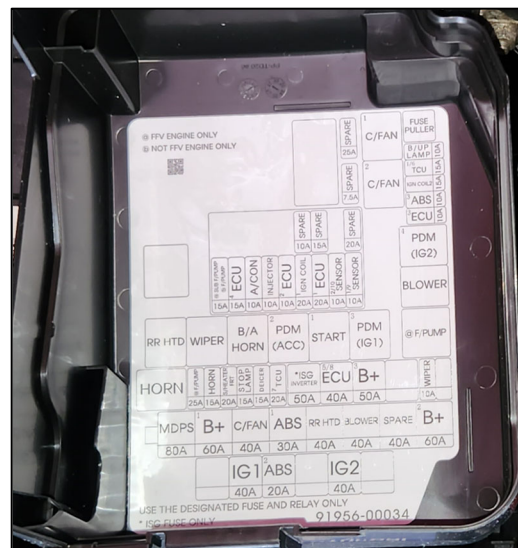
For Veloster (FS) ABS2 fuse location, the supplied 20A label may slightly exceed the boundary printed on the original fuse cover.
