SIB 32 03 23

### RECALL 23V-700: STEERING WHEEL GROUND CONNECTIONS

This Service Information Bulletin (Revision 3) replaces SI B32 03 23 **dated October 2023**.

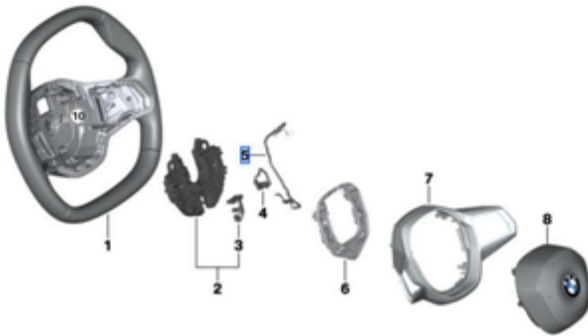
A ground wire might not be properly fastened in the steering wheel. This can cause a loose connection which indicates hands are ON the steering wheel even when being driven with hands-off.

1. BEV models only: Deactivate the high voltage system following the repair instructions listed in ISTA/AIR 61 25 900.

2. Remove the steering wheel airbag following the repair instructions listed in ISTA/AIR 32 34 030 and check the ground screw.
