SIB 11 09 23

2023-12-13

RECALL 23V-707: REPLACE VANOS ADJUSTMENT UNIT SCREWS

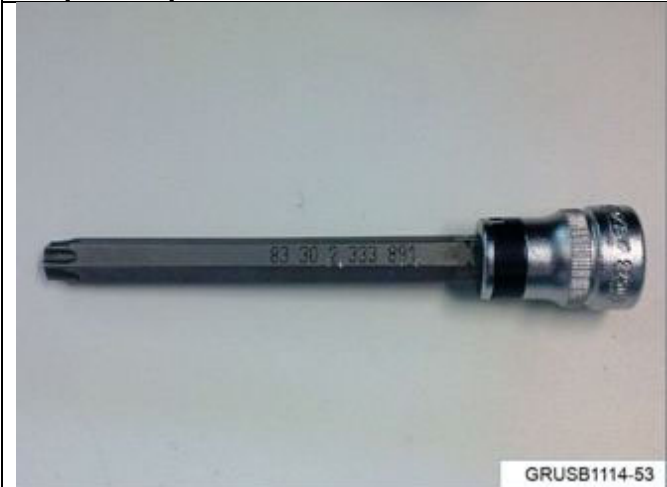
<p>Socket for Torque Wrench</p> <p>P/N 83 30 2 333 891</p> <p>Distributed via Automatic Tool Shipment. Refer to SI B04 08 14.</p>

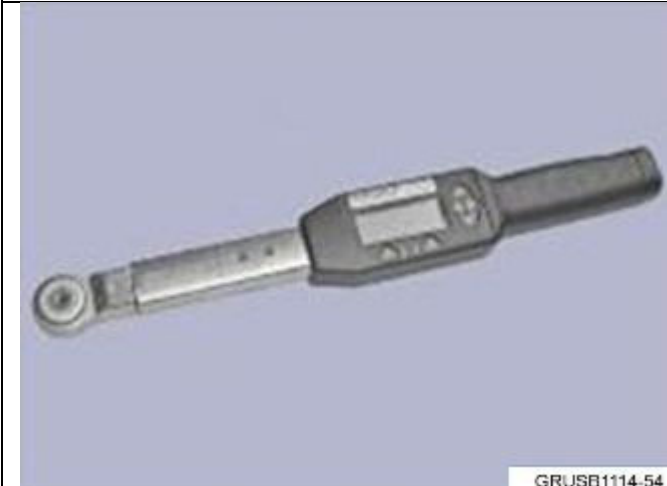
<p>Torque Wrench</p> <p>P/N 81 64 0 418 185</p> <p>Distributed via Automatic Tool Shipment. Refer to SI B04 08 14.</p>
