SIB 11 09 23

RECALL 23V-707: REPLACE VANOS ADJUSTMENT UNIT SCREWS

This Service Information Bulletin (Revision 8) replaces SI B11 09 23 **dated March 2025**.

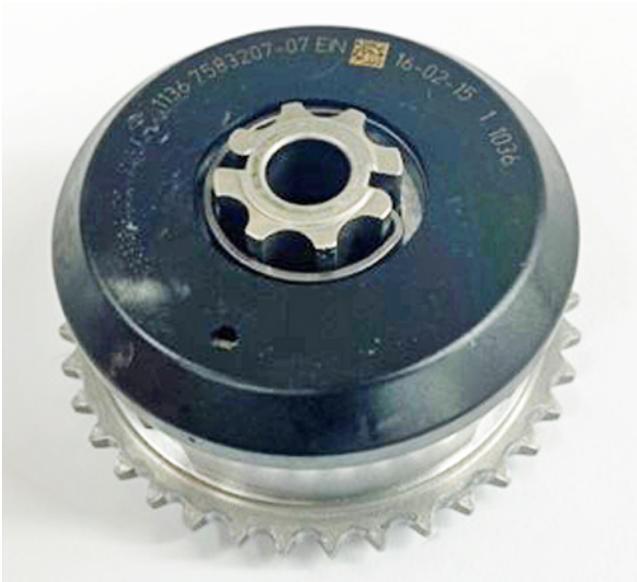
Top/side view with impulse sending wheel installed:

The exterior of the intake and exhaust VANOS gears are essentially identical in construction except for a part number difference.

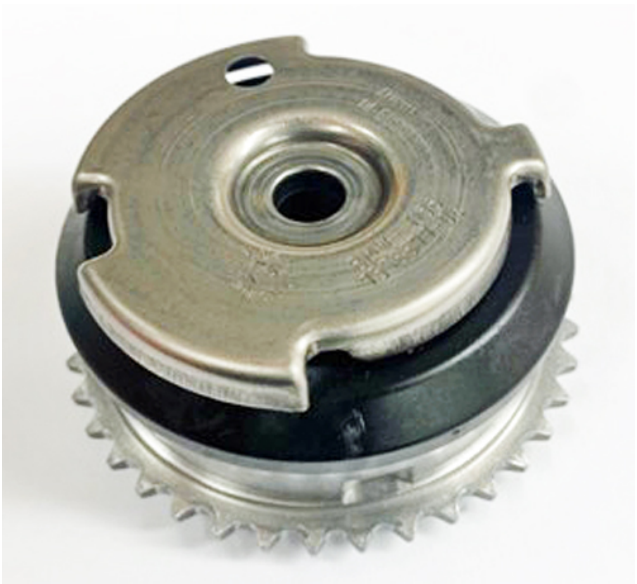
Front view with impulse sending wheel removed:

The exterior of the intake and exhaust VANOS gears are essentially identical in construction except for a part number difference.
