SIB 11 09 23

RECALL 23V-707: REPLACE VANOS ADJUSTMENT UNIT SCREWS

This Service Information Bulletin (Revision 7) replaces SI B11 09 23 **dated October 2024**.

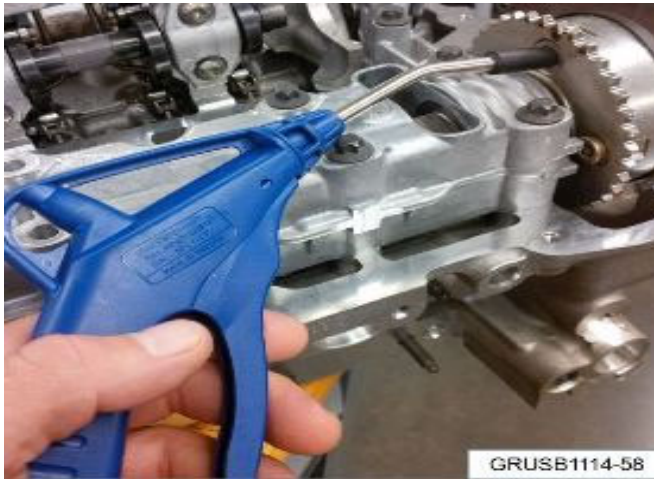
4. Turn the engine by hand using a suitable tool on the crankshaft central bolt to align one of the bolts (1) as shown in the illustration.

Remove the bolt (1) using the required special tool (2).
