SIB 11 09 23

RECALL 23V-707: REPLACE VANOS ADJUSTMENT UNIT SCREWS

This Service Information Bulletin (Revision 6) replaces SI B11 09 23 **dated October 2024**.

BMW AG is conducting a Voluntary Safety Recall (effective October 23, 2023) on a certain number of Model Year 2010 - 2013 BMW vehicles that were produced between September 2, 2009, and July 12, 2012.

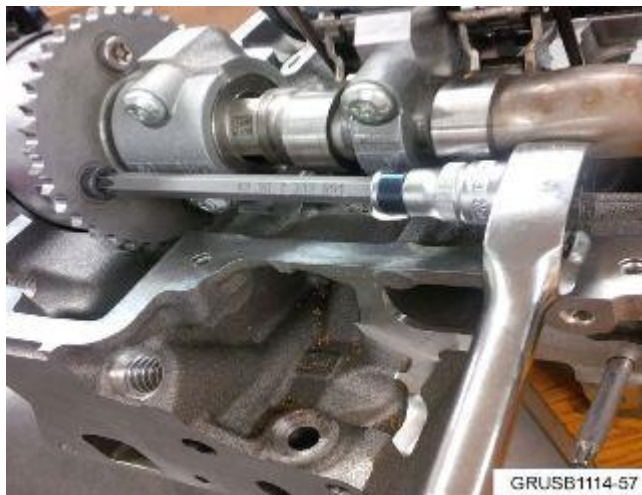
4. Turn the engine by hand using a suitable tool on the crankshaft central bolt to align one of the bolts (1) as shown in the illustration.

Remove the bolt (1) using the required special tool (2).
