SAFETY RECALL 23TA12

Front Lower Bumper Cover Assembly May Detach While Driving

CERTAIN 2020-2023 MODEL YEAR HIGHLANDER AND HIGHLANDER HV

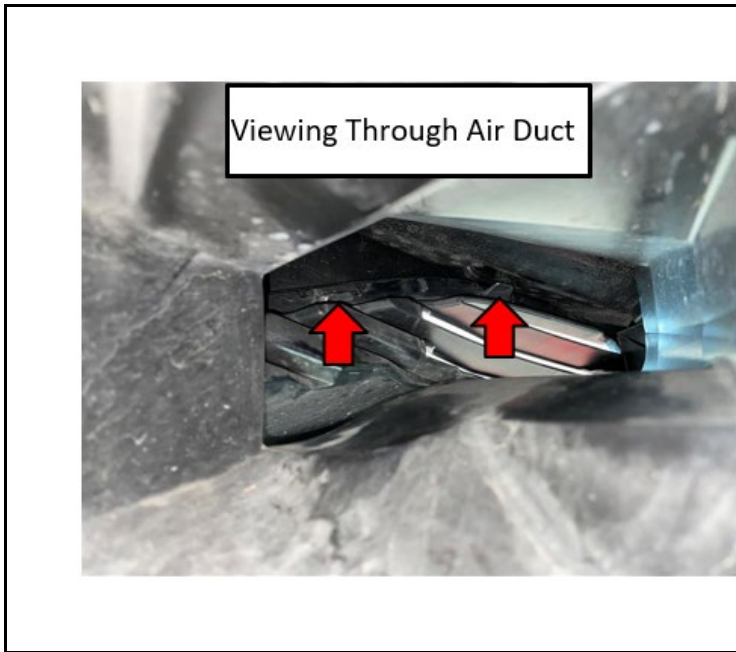
5. INSPECT FRONT BUMPER COVER CLAWS

a) Check for damage on the 4 claws (shown in the picture) and check that all the claws are engaged.

If the claws cannot be easily seen, use a mirror.

b) If disengaged claws were found in step “a”, properly engage them.
