# XOS Technical Service Bulletin

Bulletin No.: REC-003-23

Subject: Electronic Parking Brake May Fail

Applicability: Xos 2021-2022 SV05, Xos 2021 SA01, Xos 2021-2022 RM01

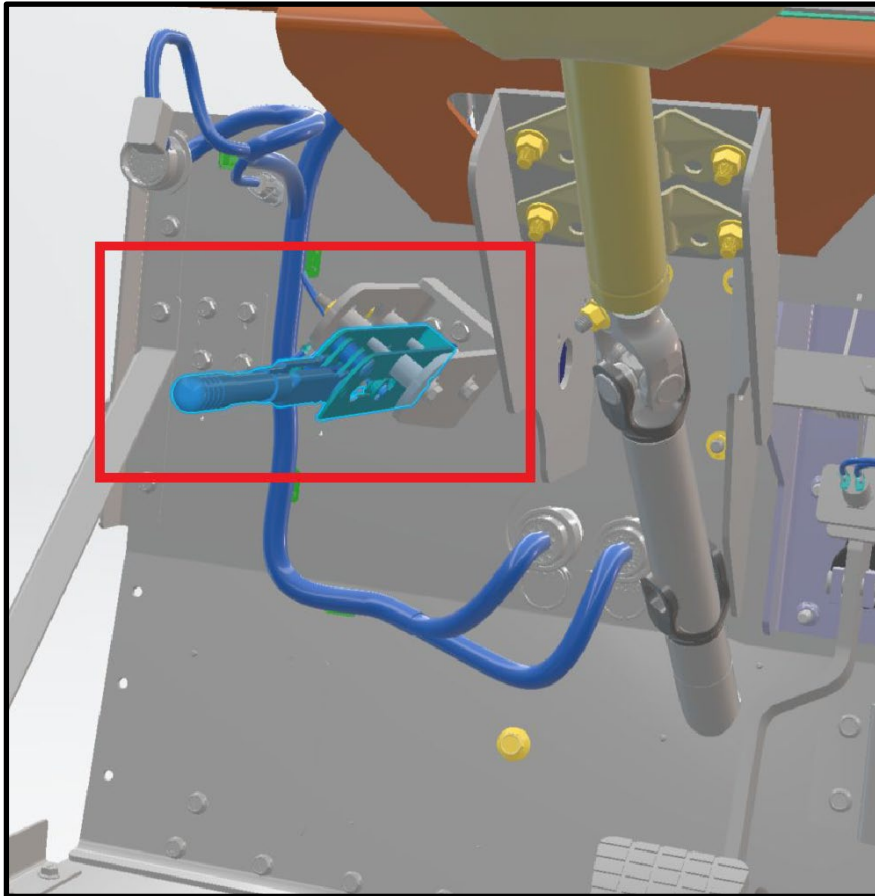
**Image 1 – Verify that the hand brake is applied**

1. **Confirm the affected VIN. Prior to reworking the EPB, turn the vehicle on. Verify that the hand brake is applied and then set the vehicle to Neutral on the shifter.**

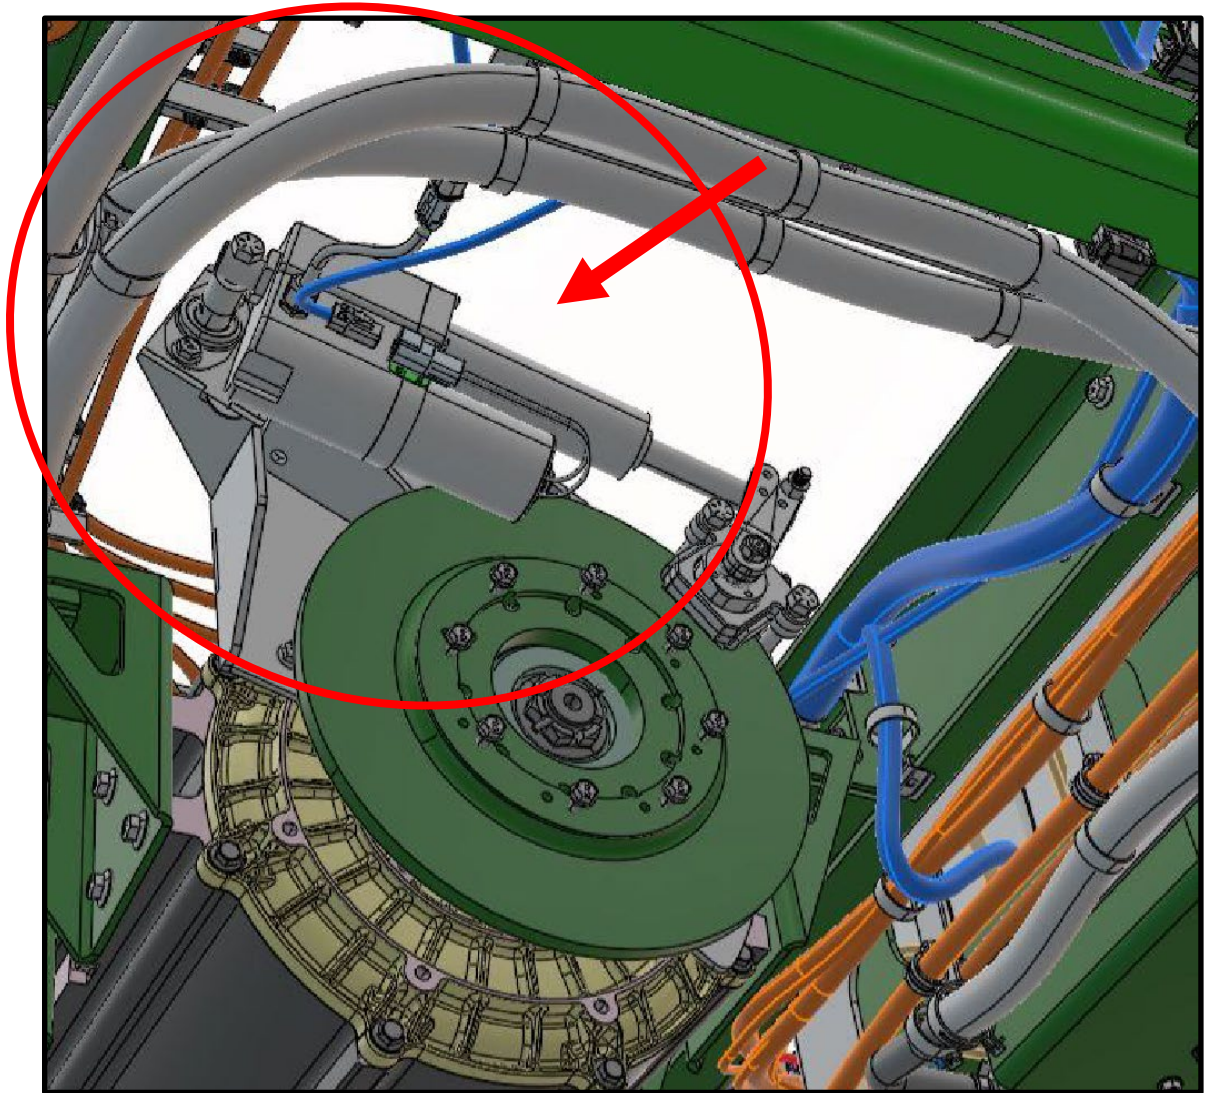
**Image 2 – Locate the EPB between the motor and the driveshaft**

2. Locate EPB on vehicle. The EPB is attached to the rear of the traction drive motor, located between the motor and the driveshaft.

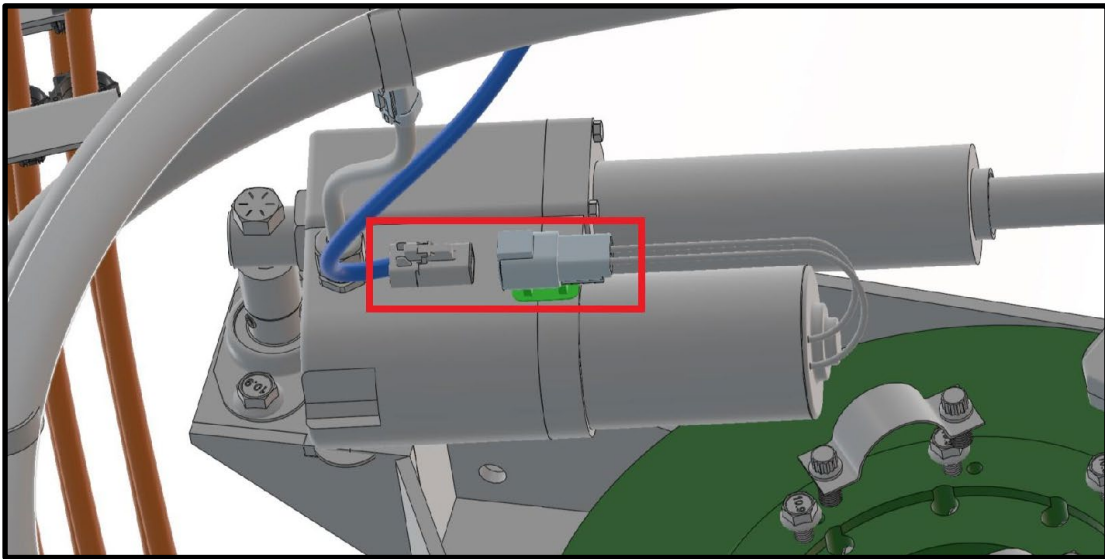
**Image 3: Disconnect the power connection**

**3. Under the vehicle, disconnect the power connection.**

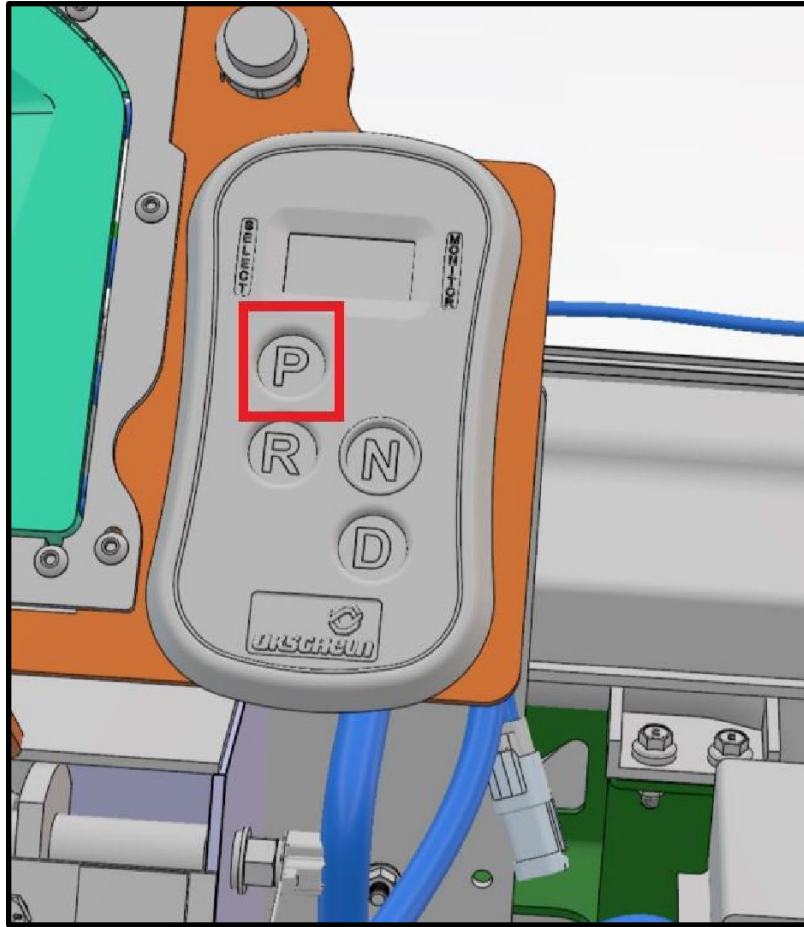
**Image 4: Select Park on the shifter and turn the vehicle off**

4. Move back into the driver's area, select park on the shifter, and turn the vehicle off.

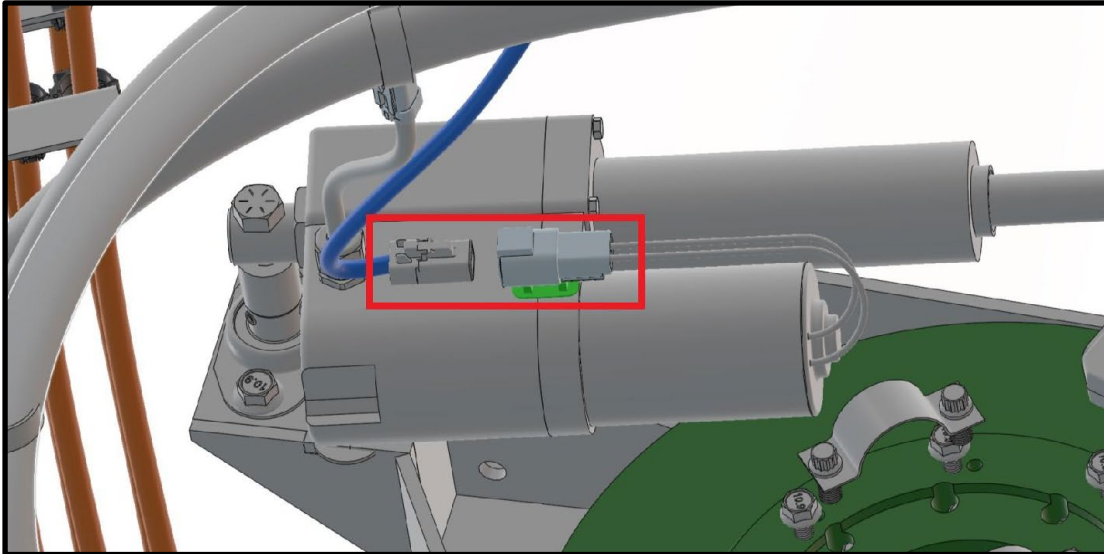
**Image 13: Reconnect the power connection.**

**13. Under the vehicle, reconnect the power connection.**
