GROUP	MODEL
Safety Recall Campaign	2023MY Soul (SK3) and 2024MY Seltos (SP2)
NUMBER	DATE
SC289	February 2024

CURTAIN AIRBAG MODULE INSPECTION AND REPLACEMENT (SC289)

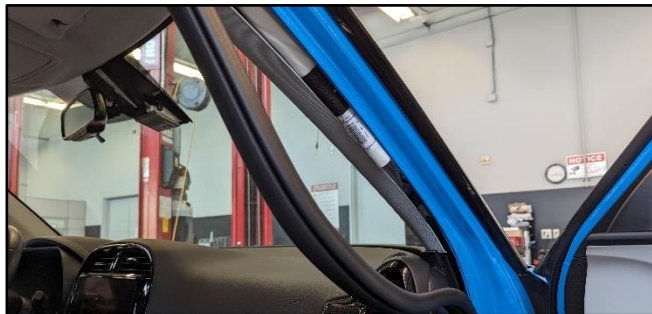
This bulletin provides information to inspect and, if necessary, replace the curtain air bag (CAB) module(s) on certain 2023MY Soul (SK3), vehicles manufactured from April 3, 2023 through May 15, 2023, and certain 2024MY Seltos (SP2) vehicles manufactured from April 3, 2023 through May 15, 2023. Due to a welding error in the stored gas section of the hybrid inflator, the side curtain airbag may inflate inadvertently without a deployment command from the Airbag Control Unit (ACU). The inadvertent inflation of the side curtain airbag increases the risk of injury to an occupant and may also create a driver distraction increasing the risk of a crash. Follow the procedure outlined in this publication to inspect and, if necessary, replace the affected module(s) with a new one. Before conducting the procedure, verify that the vehicle is included in the list of affected VINs.
