# Safety Recall

## N232425642 Right Roof Rail Airbag Inflator May Rupture

**Release Date:** September 2024

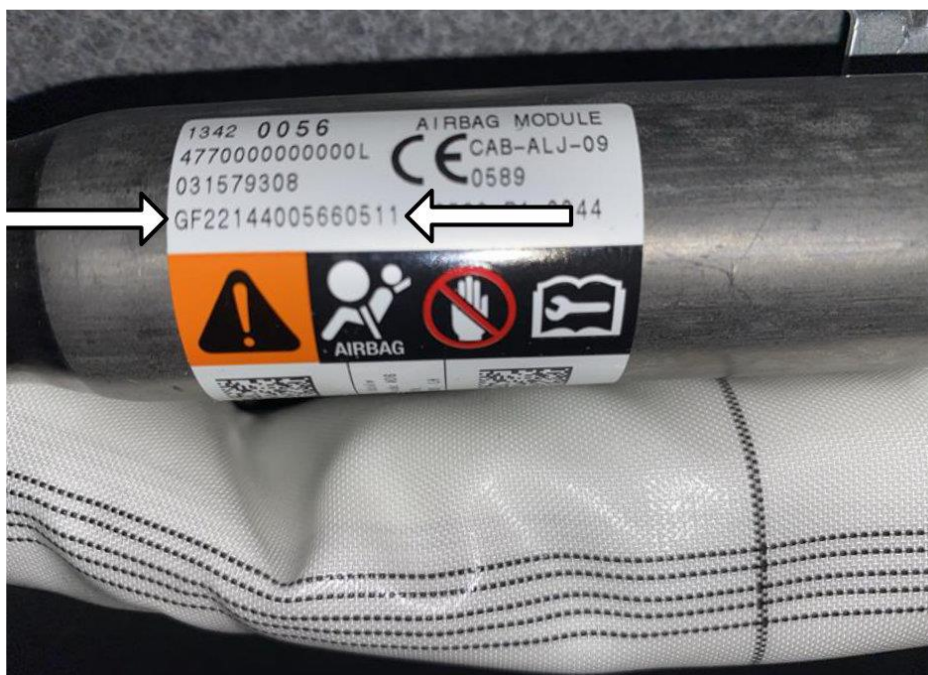
6542425

**Important: (TECHNICIAN and WARRANTY ADMINISTRATOR) SERIAL NUMBER RECORDING REQUIREMENT.** The replacement roof rail airbag serial number must be captured by the technician and recorded on the job card. The Warranty Administrator **MUST** enter the serial numbers in GWM (Global Warranty Management) or in DMS (Dealer Management System). Enter the serial number of the **replacement airbag** in the 'Labor Operation Dependency Code' field per the screen shown.
