On the vehicles affected by this recall, it is necessary to add a resistor on the RH + LH turn signals as well as RH + LH low beams electrical circuits to solve an issue affecting the front RH turn signal.

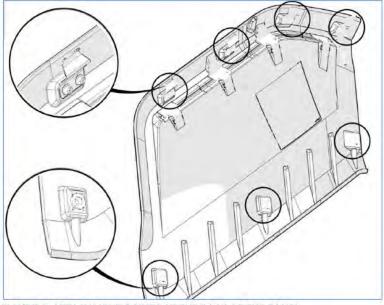
1. Remove the panel on the right side of the dashboard. The panel is secured with fasteners as seen on the images below.

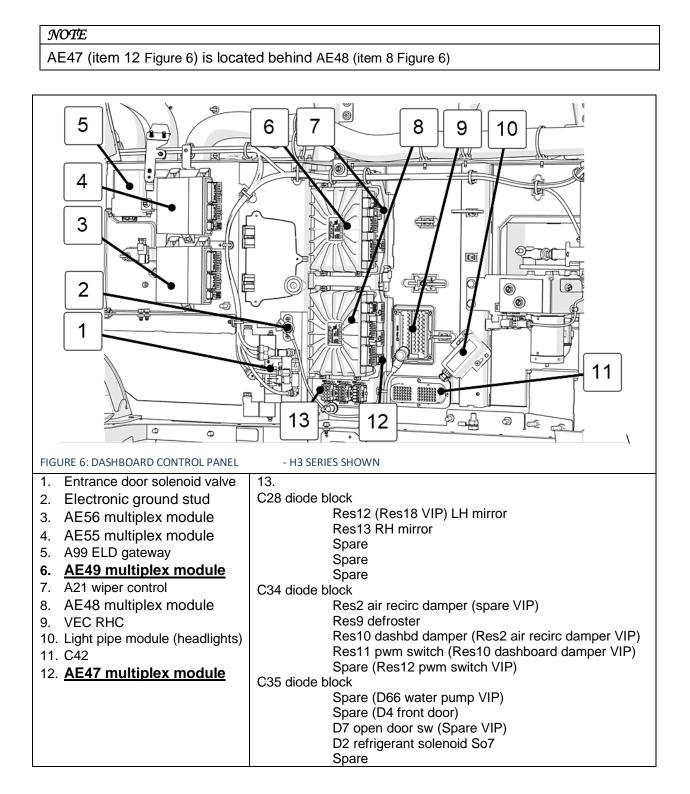
FIGURE 7: CONNECTOR RES4 LOCATION

3. On the dashboard electrical control panel, find connector RES4 located between MUX modules AE49 & AE47.
