PREVOST

**SAFETY
RECALL**

SR23-310A

DATE :	August 2023	SECTION :	18 BODY
SUBJECT:	SEAT RECLINE MECHANISM PIVOT BOLTS

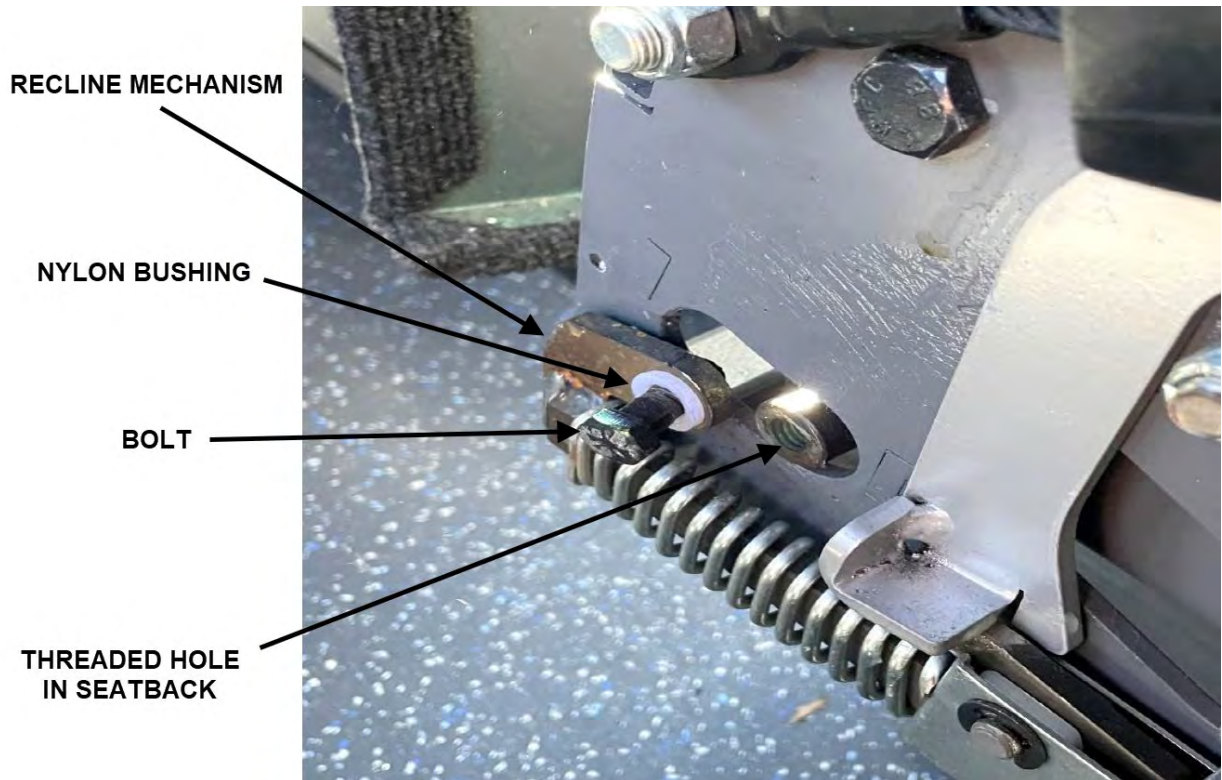
Bolts on both sides are covered by trim panels

- Remove the trim panel.
- Remove the pivot bolt.
- Add a good quality, high-strength thread-locking adhesive to the bolt threads.
- Reinstall the pivot bolt (tighten firmly).
- Reinstall the trim panel.
- Repeat for all seat bolts concerned.
