| RE: <b>Recall Campaign Launch Notification STOP DRIVE</b><br><b>Inspect and Replace Brake Booster without Pedal Rework</b><br><b>MY06-12 GL-Class, ML-Class, R-Class</b><br><b>(164 and 251 platform)</b> | DATE: May 10, 2024 |

**Inspect and Replace Brake Booster Without Pedal Rework**

Campaign No. 2024050001, May 2024

## **Inspect Brake Booster – without Pedal Rework**

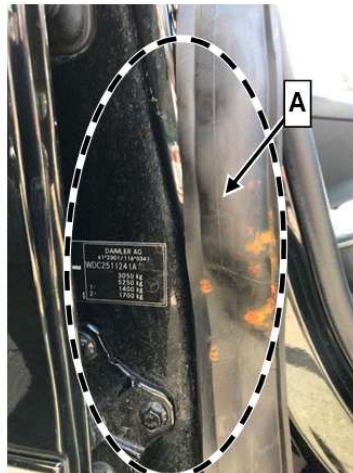
3. Take a photo of the rubber sleeve with the VIN label of the B-pillar (**Figures 3 and 4, A**) and store to a local HDD/computer storage location with the vehicle service file and attach it to the warranty claim in EVA.
  - i** These pictures serve as documentation of the current condition of the brake booster.

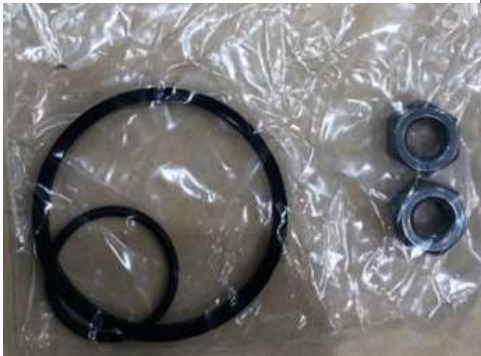
Figure 12

**i** The new brake booster contains a small parts kit (**Figure 12**).
