Lucid Group Inc. Technical Service Campaign

TSC Number: TSC-H0224-013-02	Date: 02/15/2024
Document Classification: Perform on next service visit	Model: Lucid Air
	Year: 2022-2023
Title: Coolant Heater May Fail to Defrost Windshield	Region: All Regions

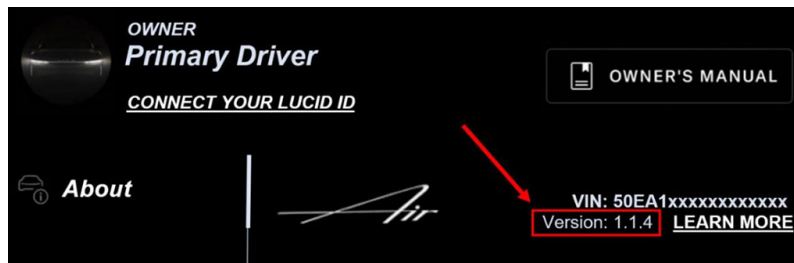
- Using the vehicle display, determine the currently installed Software version.

- Is the currently installed Software version 2.1.52 or newer?
 - YES: Proceed to **Defroster Performance Test**.
 - NO: Proceed to next step.
- Using the "OTA Service Request" tile in Lucid Garage, update to the **most current** Software version available (minimum v2.1.52). Refer to [Over The Air \(OTA\) Flashing](#).
- Check and clear DTCs. Refer to [DTCs Check and Clear](#).
- Proceed to **Defroster Performance Test**.

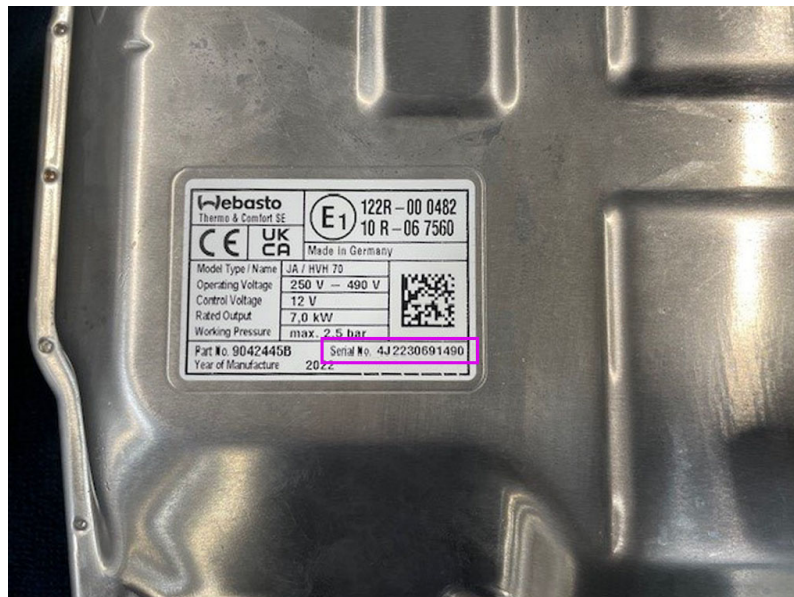
1. Capture a clear, close-up photograph of the old and new Webasto serial number sticker attached to the High Voltage Coolant Heater, ensuring all numbers are legible. Attach both photographs to the work order, and clearly label them **Original Serial Number** and **Replacement Serial Number** for easy identification.
