*****July 12, 2024 – Added warning regarding debris in steering gear*****

Safety Recall – 2024 CX-90 - Steering Gear Safety Recall

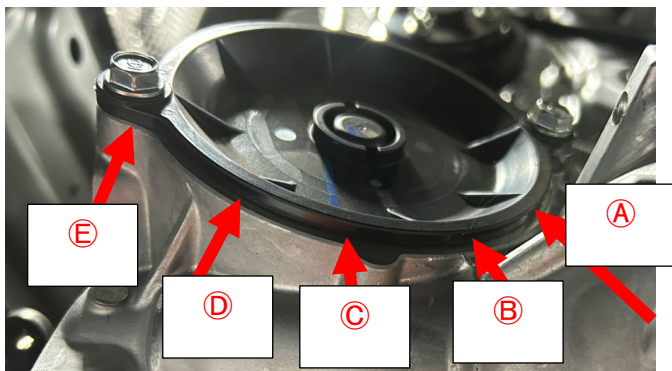
Figure C

3. Gently use a plastic door trim tool to remove the black cover so that it slowly pops up and rests against the loosened bolts (Figure C). You will need to gently insert the pry tool several times rocking the piece slowly up left-to-right (A), (B), (C), (D), and (E). Do not use any excessive force. (Figure D). There is an O-Ring on this cover that makes it difficult to remove by hand. [PLEASE CLICK HERE TO WATCH THE VIDEO OF THIS PROCEDURE STEP. \(Right Hand drive vehicle shown, but repair is the same\)](#)

Do not use a metal pry tool or flathead screwdriver, as this will cause damage/deform the aluminum case. Deformation or cracking of the black cover will allow moisture to enter the worm gear breaking down the grease resulting in rusted parts. Costs to replace damage to these components caused by incorrect tool use/improper repair will be absorbed by the Mazda dealer causing customer frustration and delay of repairs.

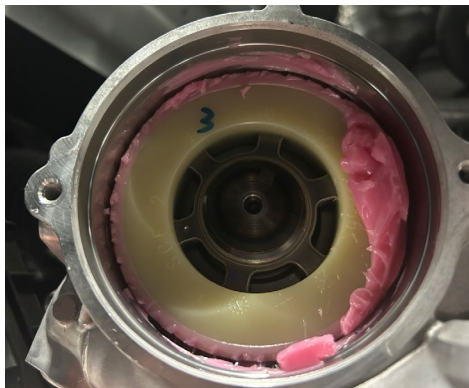
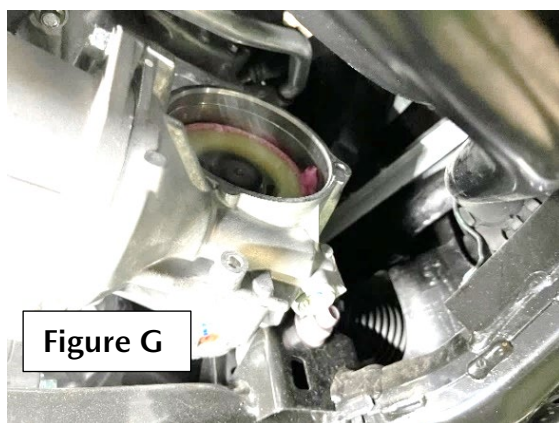
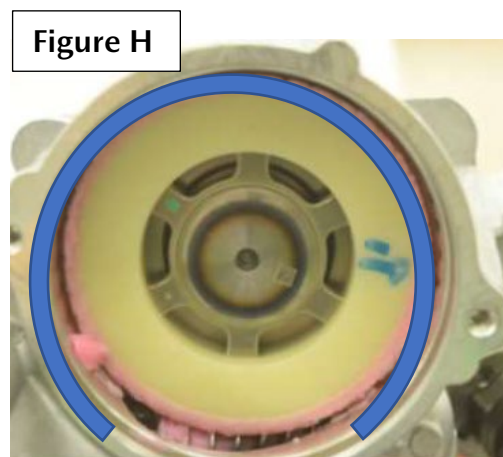
BEFORE

6. Using your gloved finger, press the grease into the gap between the aluminum case and the worm gear insert around the worm gear Figure G, which adheres to the area of the blue frame in Figure H. Note G is showing a Right Hand Drive Steering Rack.

CAUTION: Do not use grease from parts kit, and do not push grease in with your bare hands! If you work with your bare hands, dirt and foreign matter will get inside, which can result in poor steering performance or binding of the steering gear. [PLEASE CLICK HERE TO WATCH THE VIDEO OF THIS PROCEDURE STEP. \(Right Hand drive car is shown, but repair is the same\)](#)

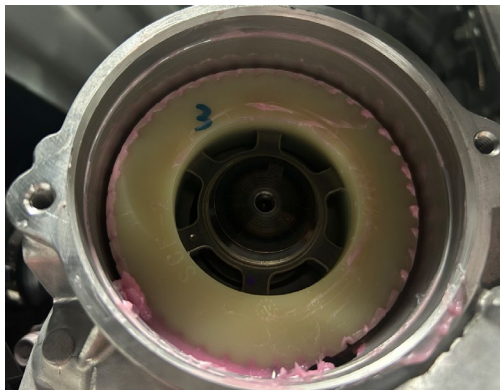
AFTER PRESSING GREASE IN

When you are done this is what this looks like. You can see that the plastic strip has pushed the grease into the teeth of the gear.

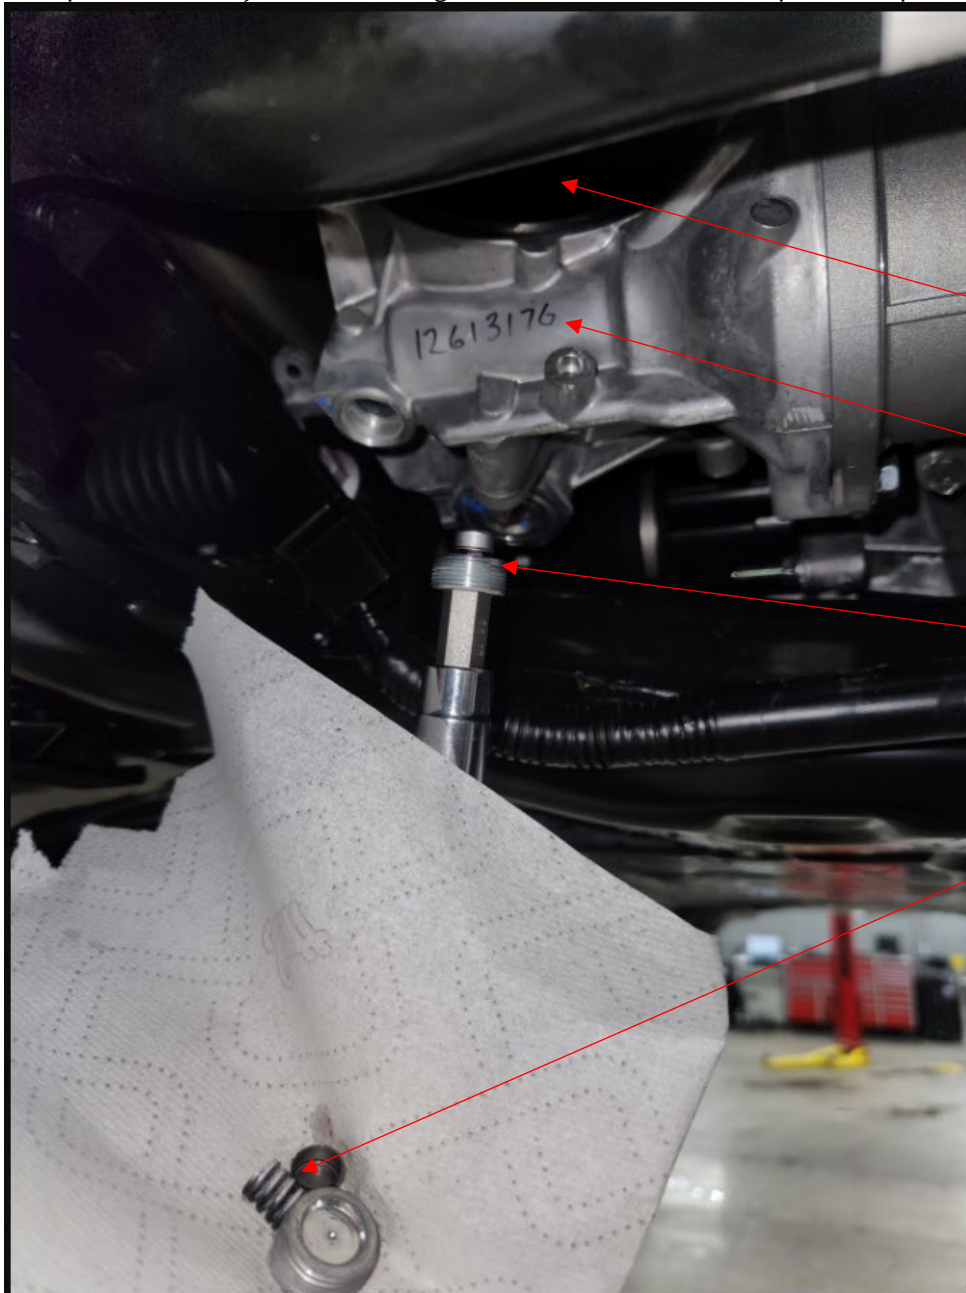
Cover is installed

RO # written on Steering Rack

New spring assembly properly assembled

Old Spring White color clearly seen and ready for discard

Write the RO# on the steering rack and take a photo so that the new integrated cap, spring, end cap are ready to be installed, and old spring which will be discarded are all visible. See photo example. This must match. See the RO# written on the rack. Make sure the RO# is present in the photo.
