GROUP	MODEL
Safety Recall Campaign	2023-2024MY Sportage (NQ5a) and 2022-2024MY Carnival (KA4) <u>without Roof Rails</u>
NUMBER	DATE
SC292 (Rev 1, 10/24/2024)	March 2024

ROOF MOLDING INSPECTION, RETENTION AND REPLACEMENT (SC292)

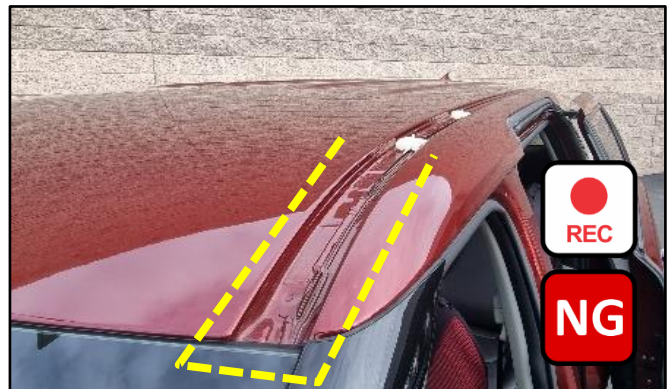
Note: Use very 'light' upward pressure to verify if the roof molding is not secured/loose/detached. DO NOT try to forcefully pry up the roof molding.

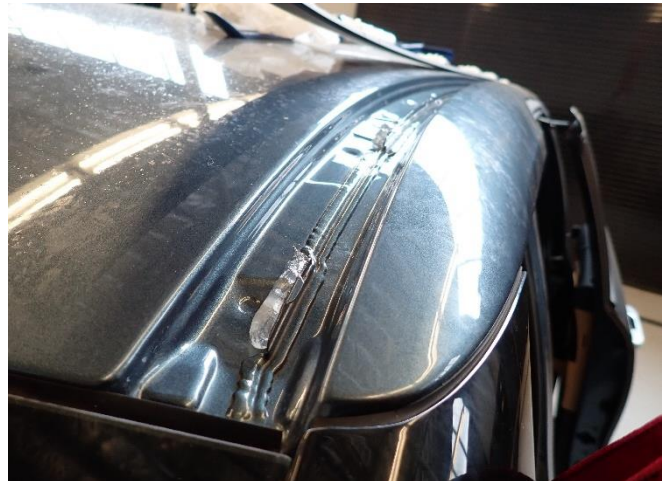
Note: Carnival (KA4) is shown for reference.

1b. **Sportage (NQ5a):** Refer to pages 4-5, steps 2b-3 of the 'Repair Procedure' to:

- Do Not cut any clips
- Apply sealant to the two body tabs
