GROUP	MODEL
Safety Recall Campaign	2023-2024MY Sportage (NQ5a) and 2022-2024MY Carnival (KA4) <u>without Roof Rails</u>
NUMBER	DATE
SC292 (Rev 3, 12/22/2025)	March 2024

ROOF MOLDING INSPECTION, RETENTION AND REPLACEMENT (SC292)

This bulletin provides information to inspect and, if necessary, secure or replace the roof molding on certain 2023-2024 Sportage (NQ5a) vehicles produced from January 12, 2022 through November 29, 2023, and certain 2022-2024 Carnival (KA4) vehicles (not equipped with roof rails) produced from January 5, 2021 through November 24, 2023. The roof molding may become loose or detach under certain circumstances either due to interference of the roof molding retaining clip(s) with excessive roof panel sealer or due to improper installation of the roof molding during vehicle assembly. A detached roof molding can create a road hazard for other vehicles, increasing the risk of a crash. Follow the procedure, outlined in this publication to inspect the roof moldings, and if necessary, secure the affected molding or replace and secure it with a new part. Before conducting the procedure, verify that the vehicle is included in the list of affected VINs.

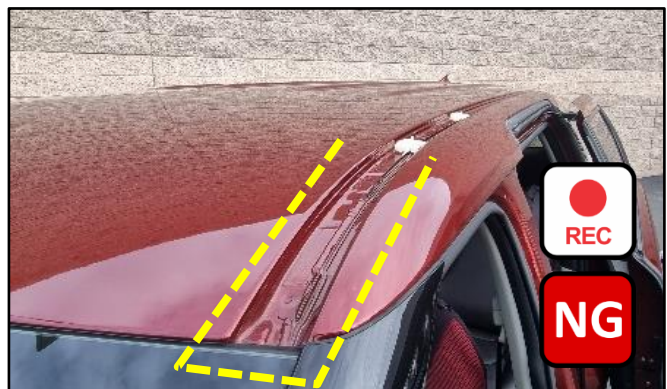
Note: Use very 'light' upward pressure to verify if the roof molding is not secured/loose/detached. DO NOT try to forcefully pry up the roof molding.

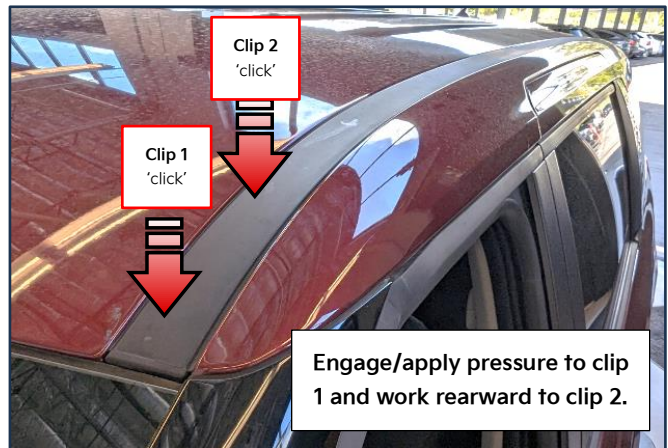
- 5a. Verify that there is no overlap or gap between the molding and the windshield header weatherstrip (OK).
- 5b. If the roof molding is not aligned correctly (NG), repeat the previous steps needed to correct and align properly.

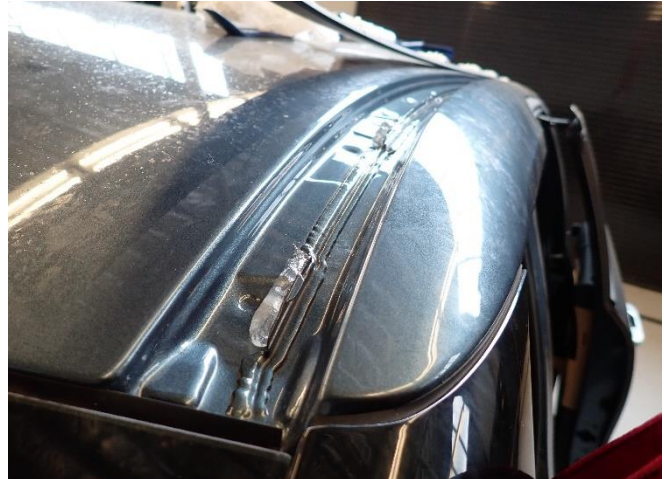
Note: Carnival (KA4) is shown for reference.

1b. **Sportage (NQ5a):** Refer to pages 4-5, steps 2b-3 of the 'Repair Procedure' to:

- Do Not cut any clips
- Apply sealant to the two body tabs

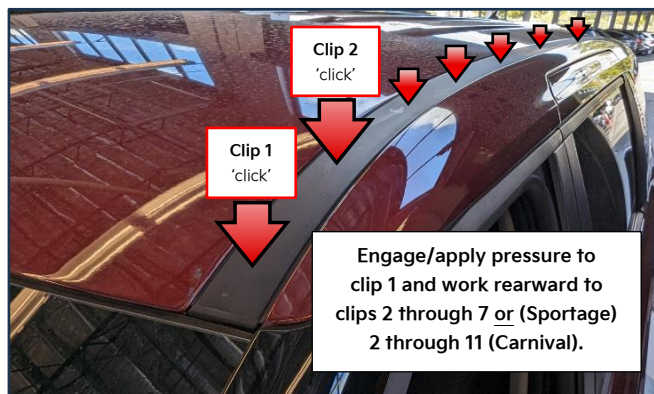
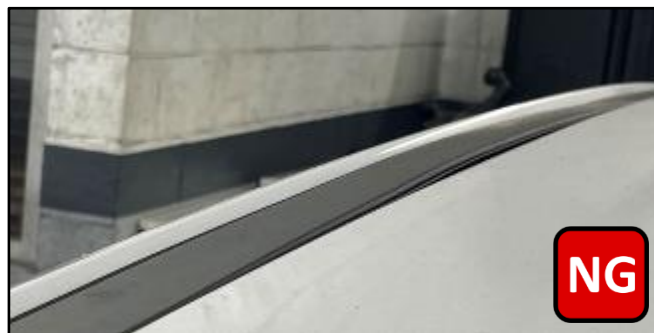
- 4a. Verify that there is no overlap or gap between the molding and the windshield header weatherstrip (OK).

- 4b. If the roof molding is not aligned correctly (NG), repeat the previous steps needed to correct and align properly.
