GROUP	MODEL
Safety Recall Campaign	2023-2024MY Sportage (NQ5a) and 2022-2024MY Carnival (KA4) without Roof Rails
NUMBER	DATE
SC292	March 2024

SAFETY RECALL CAMPAIGN

ROOF MOLDING INSPECTION, RETENTION AND REPLACEMENT (SC292)

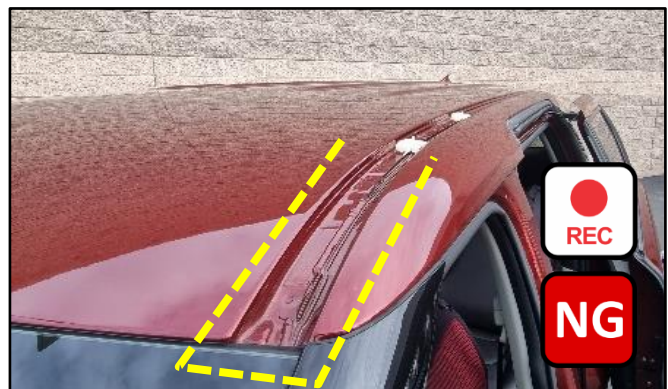
Note: Use very 'light' upward pressure to verify if the roof molding is not secured/loose/detached. Do not try to forcefully pry up the roof molding.
